A Special Wetland Eversource Energy's Atlantic White Cedar Mitigation Project - The 1st Year

BSC Group, Inc.

THE PROJECT: Eastern Connecticut Reliability Zone 5 400/500 Lines Rebuild

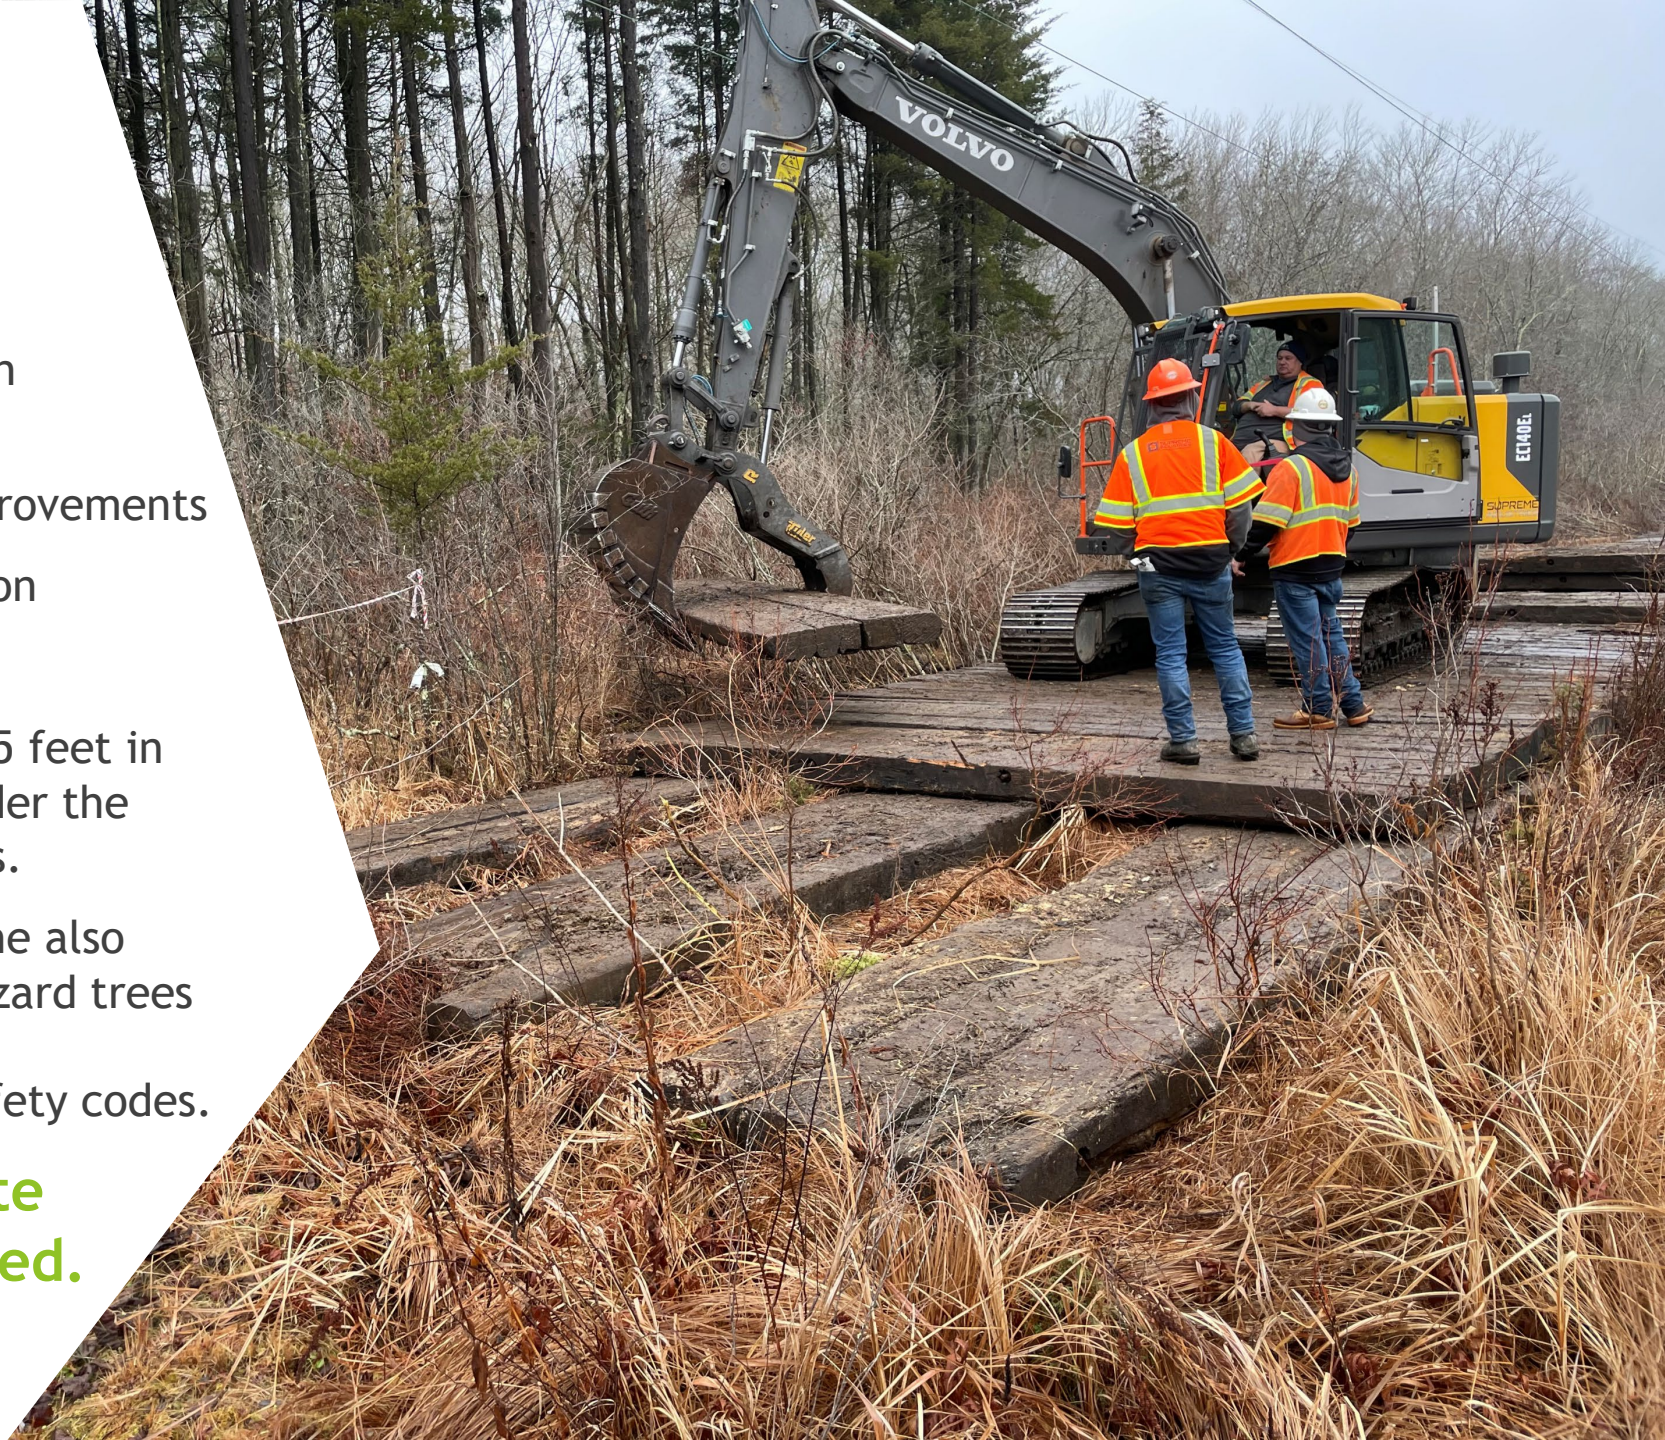
Feller-bunchers were used to extract AWC without causing disturbance to the surrounding areas.

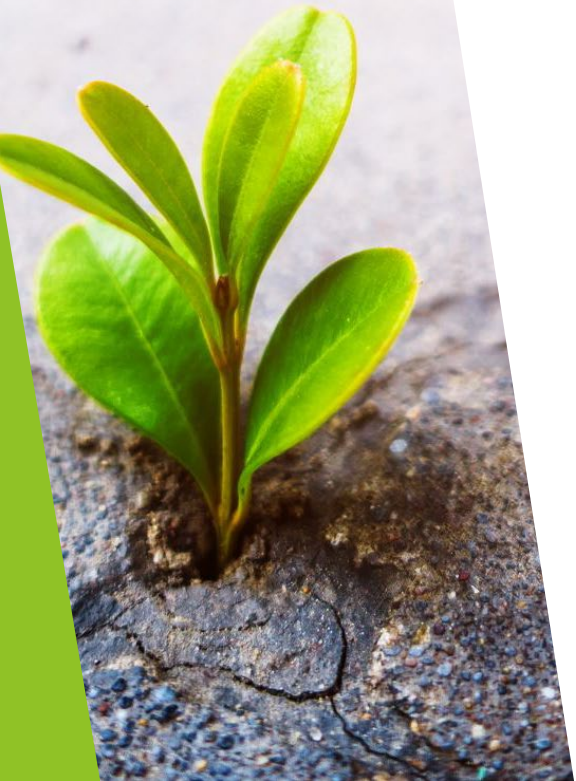
Protective fencing removal cannot be removed until BOTH of the following conditions have been met:

- a. Planted AWC have reached 10 feet in height
- b. Qualified expert determines the trees can survive buck rubbing and deer browse and approved by CT DEEP.

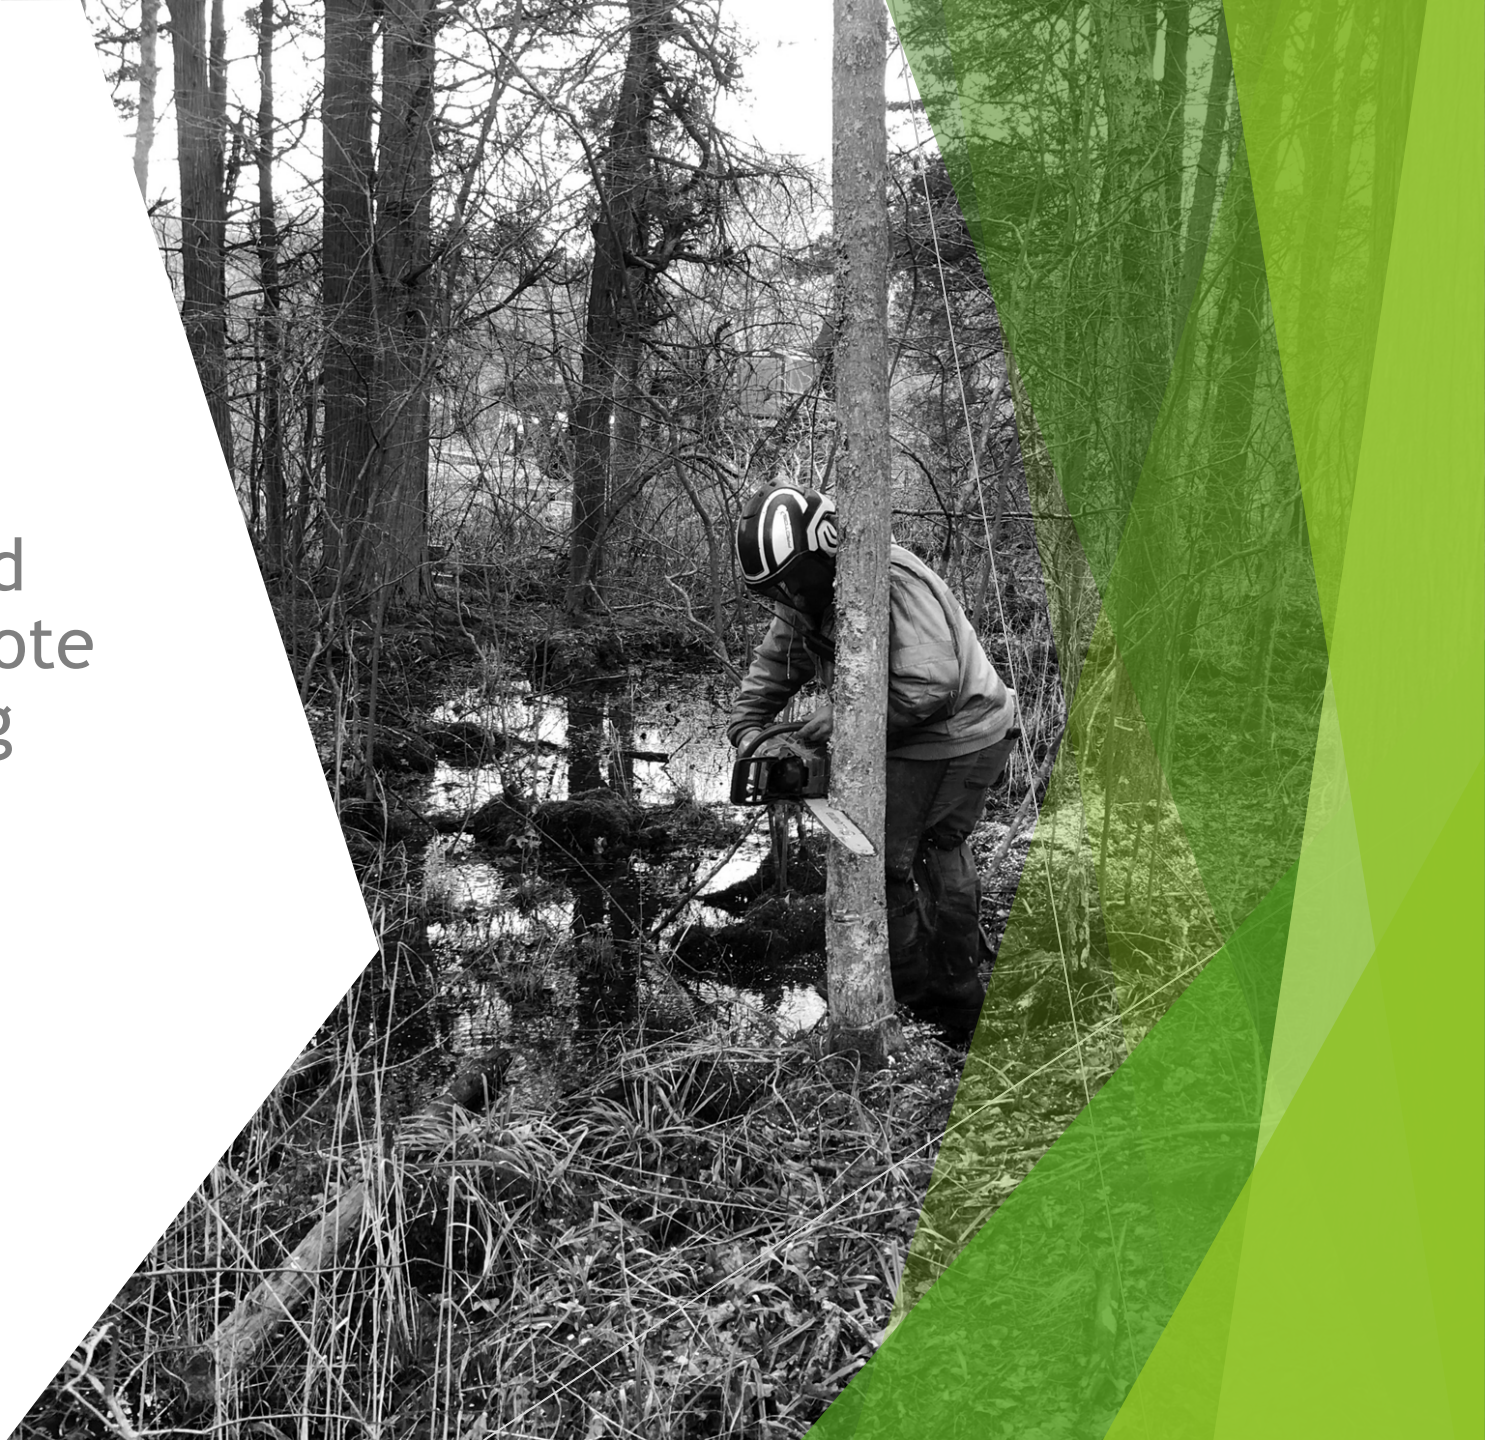
AWC MITIGATION PLAN IMPLEMENTATION STEP 1: ENHANCEMENT

Hardwood tree felling and girdling conducted to promote the health of the existing stand.

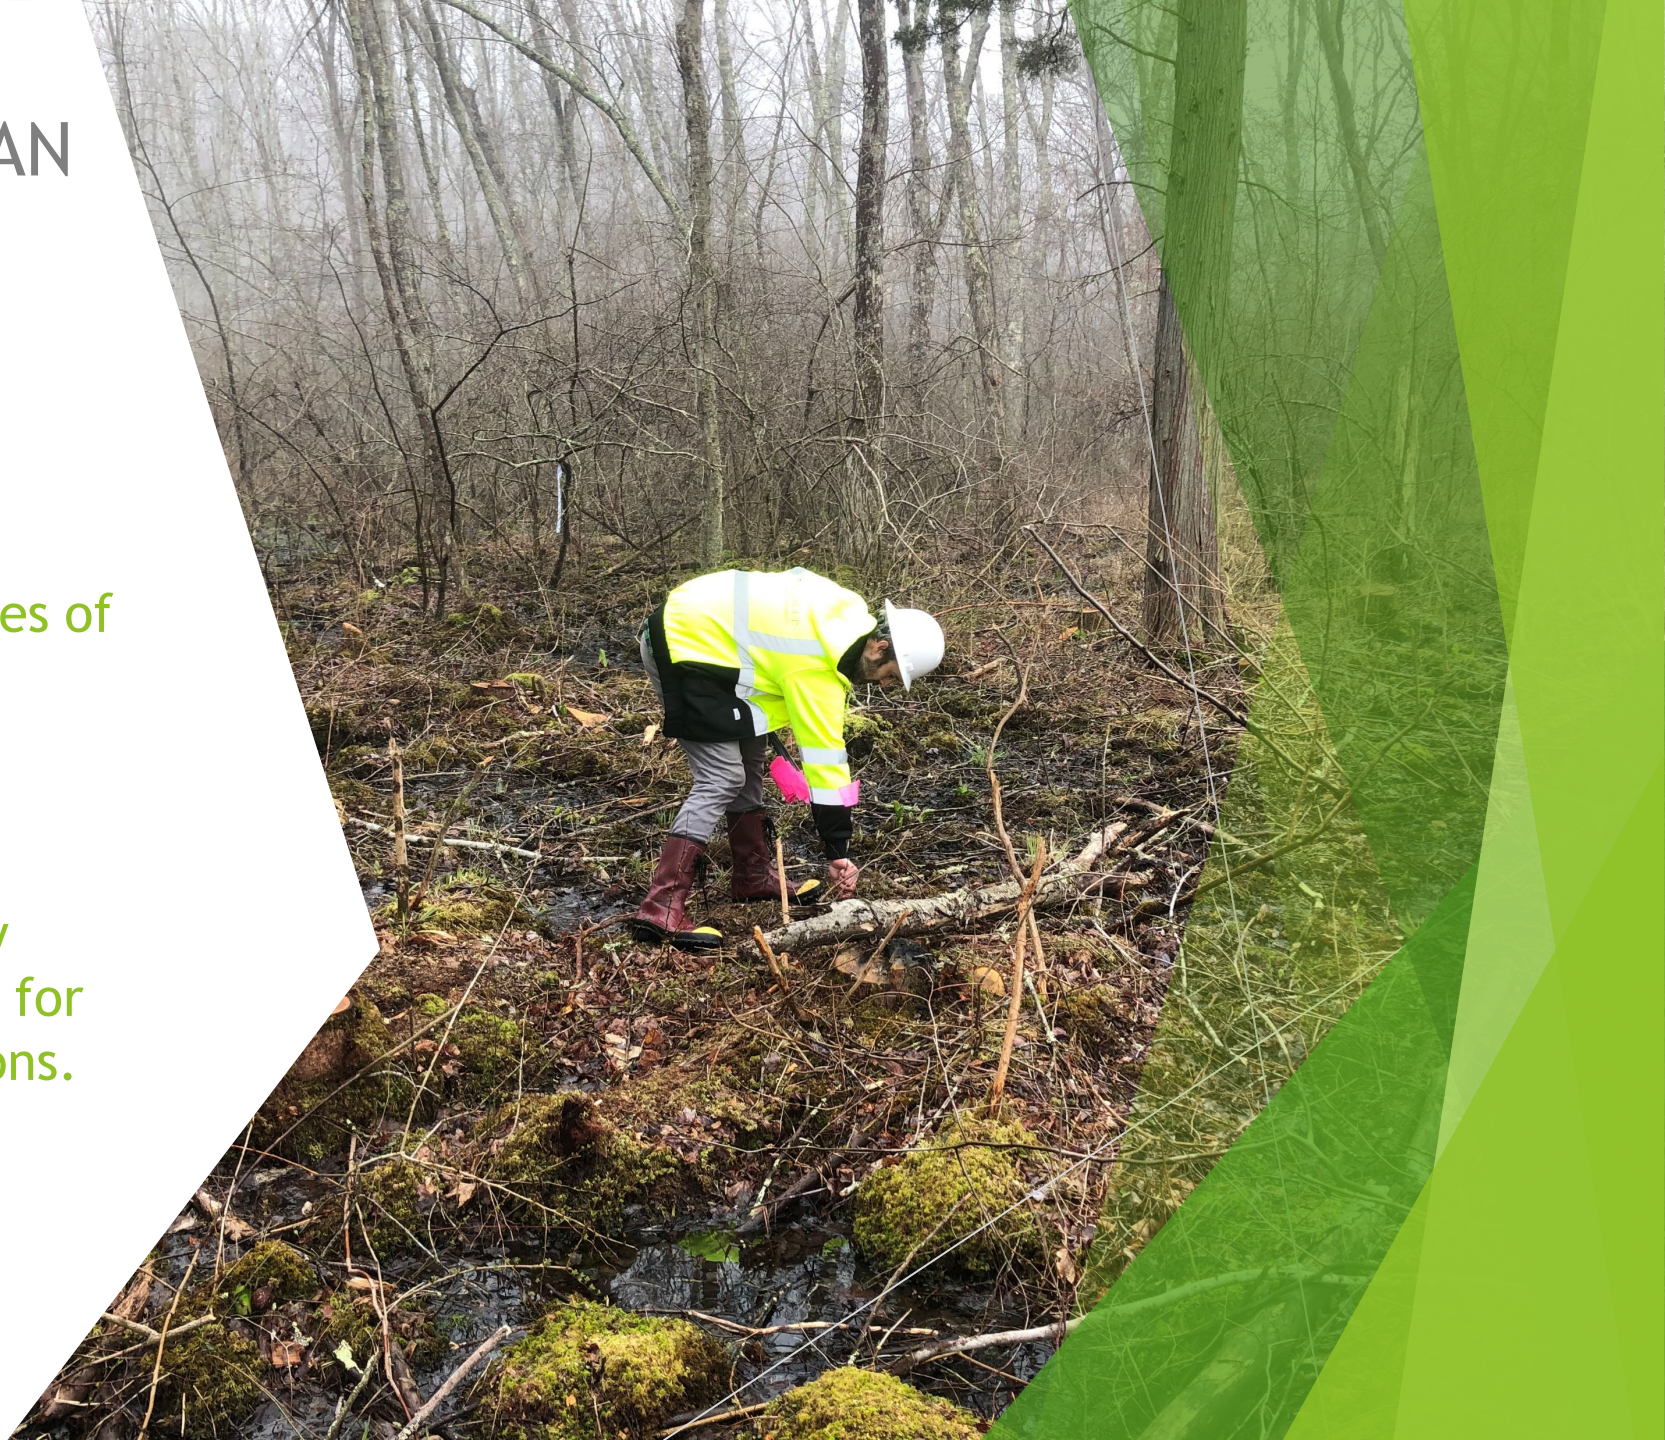
AWC MITIGATION PLAN IMPLEMENTATION STEP 2: CREATION

- Tree removal conducted to enhance the saplings' chances of survival by decreasing competition and promoting natural regeneration.
- Areas with microtopography (i.e. tussocks) were flagged for appropriate planting locations.

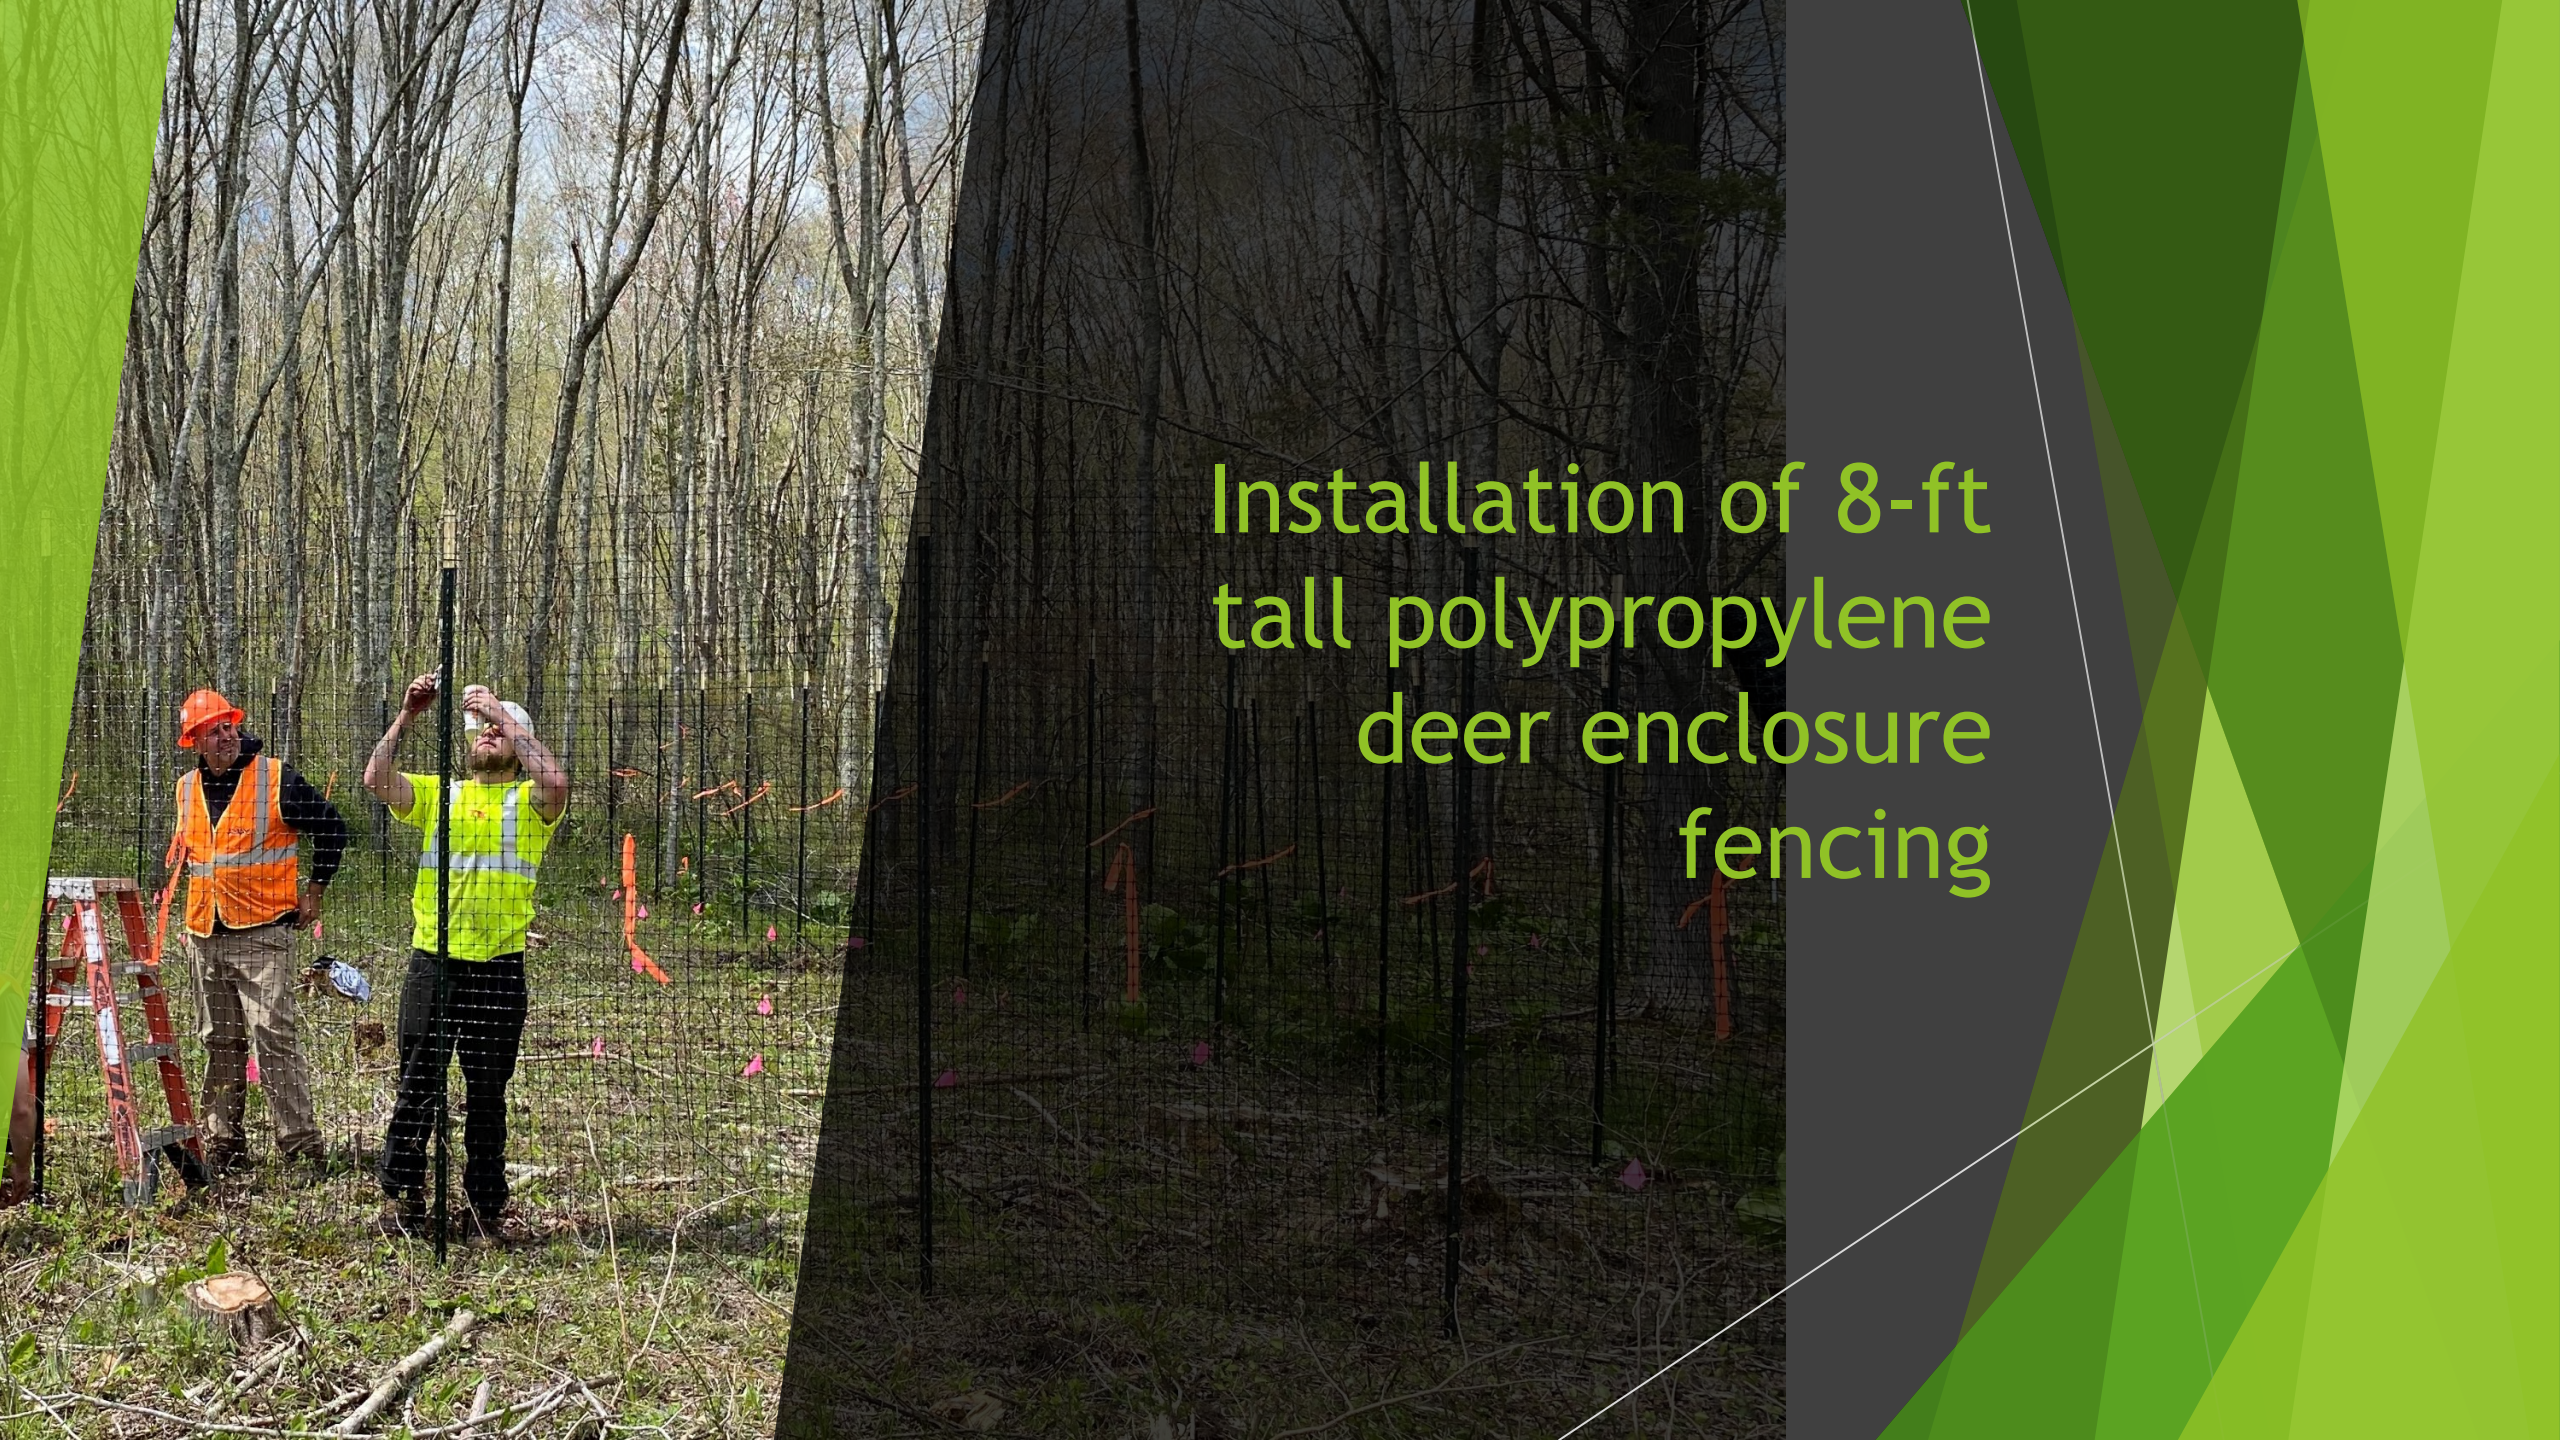
Installation of 8-ft tall polypropylene deer enclosure fencing

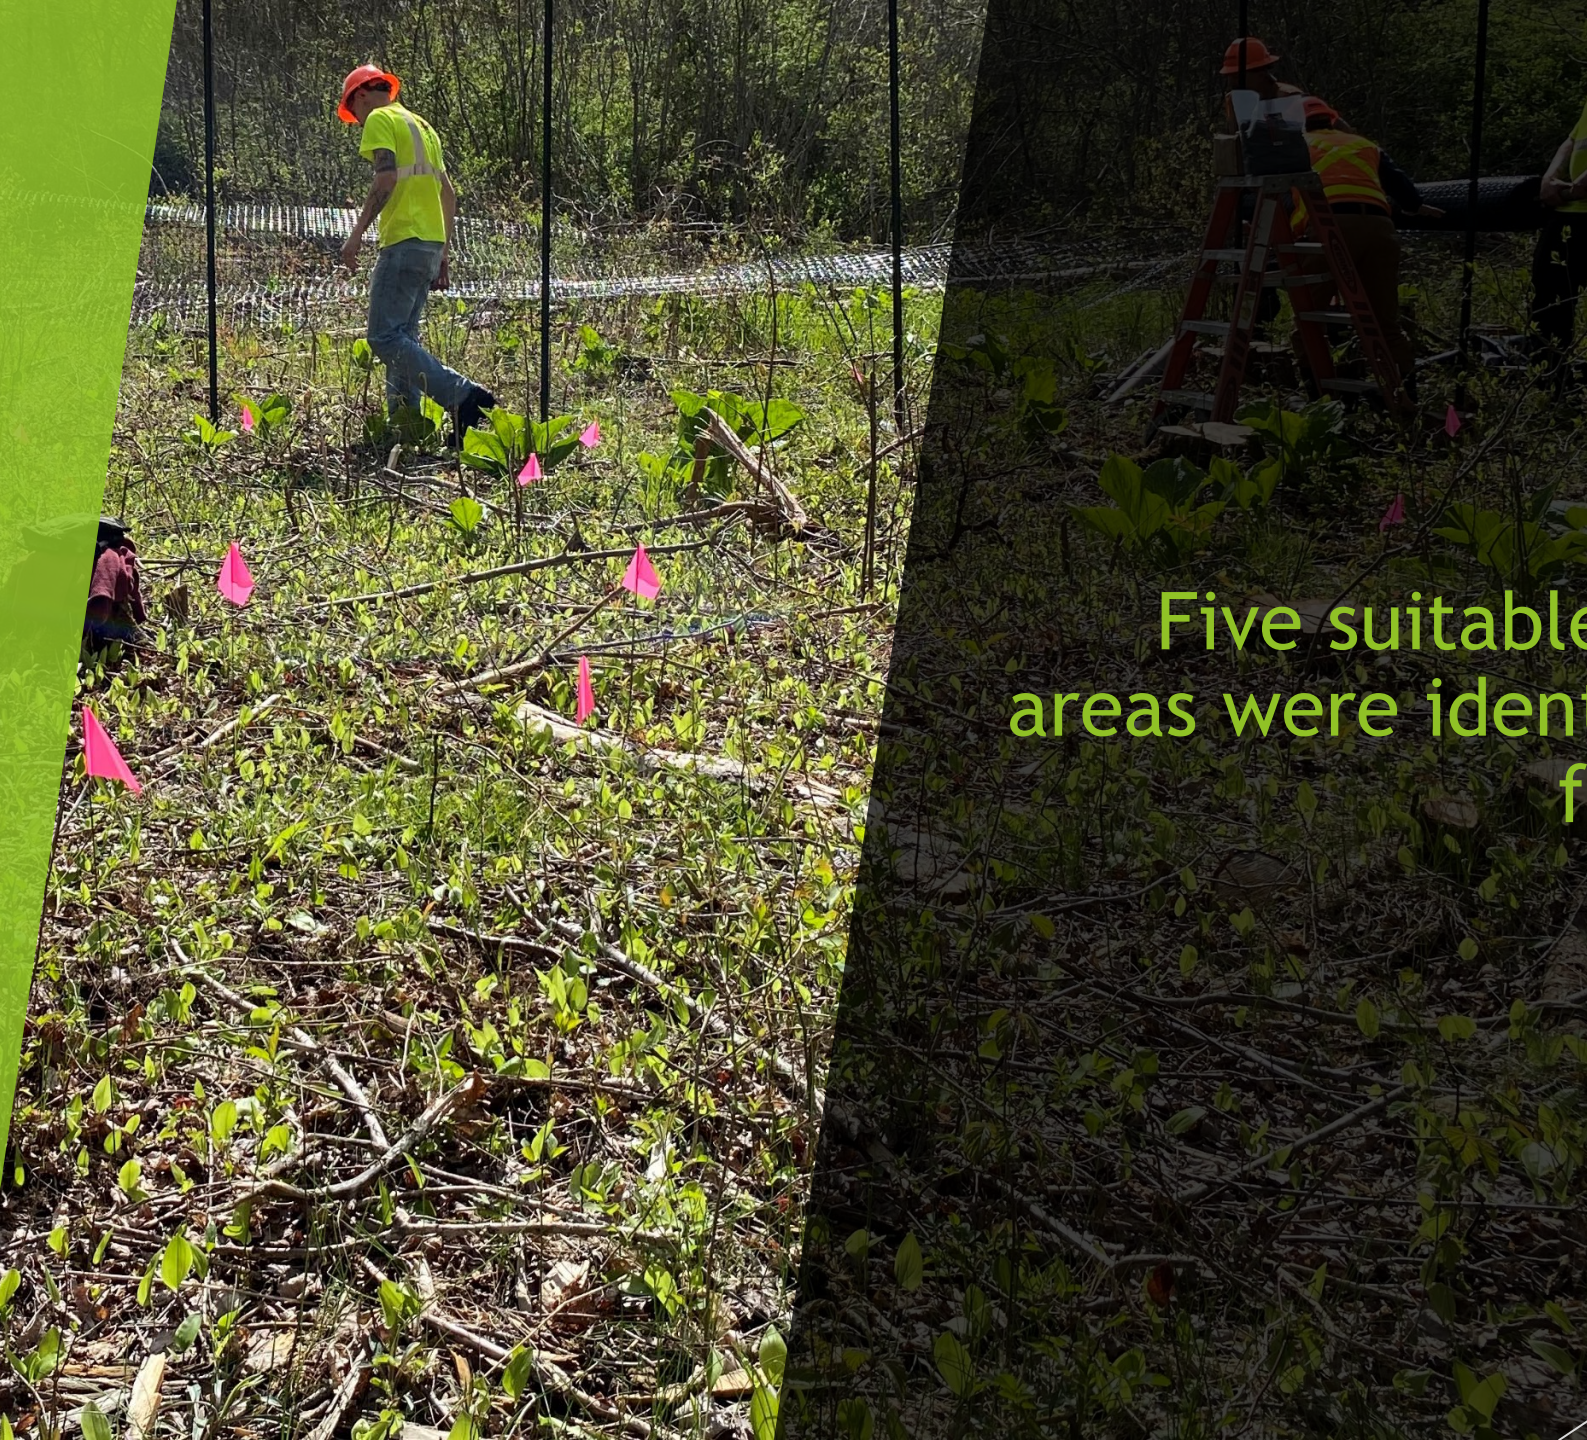
Five suitable planting areas were identified and fenced off

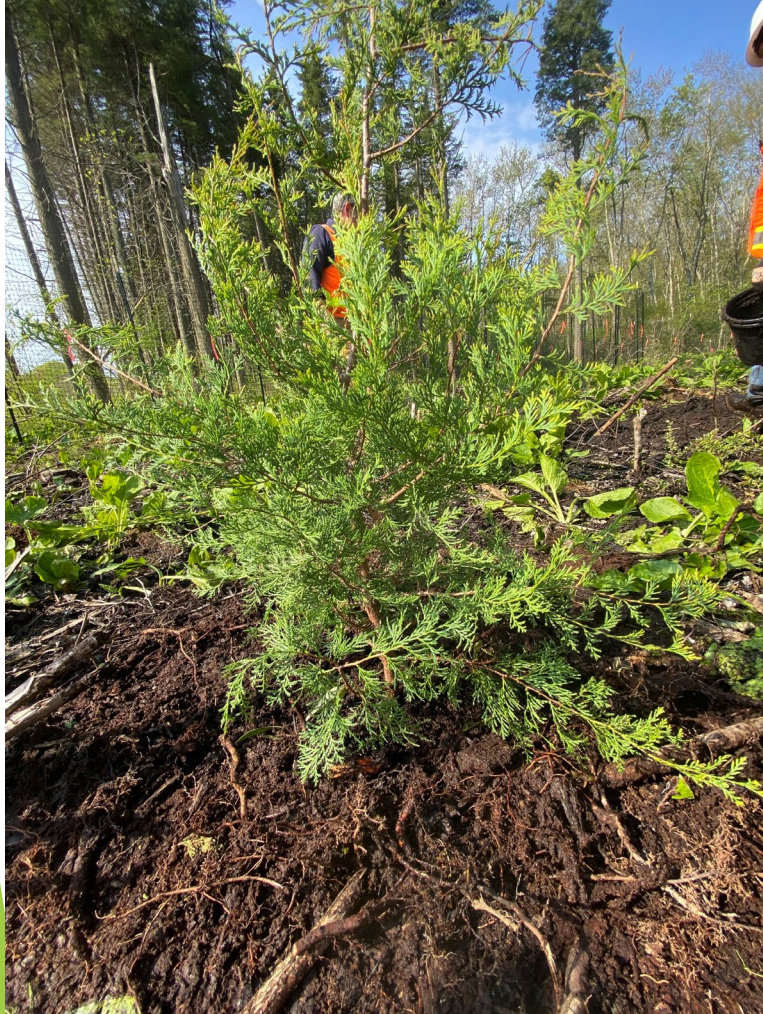
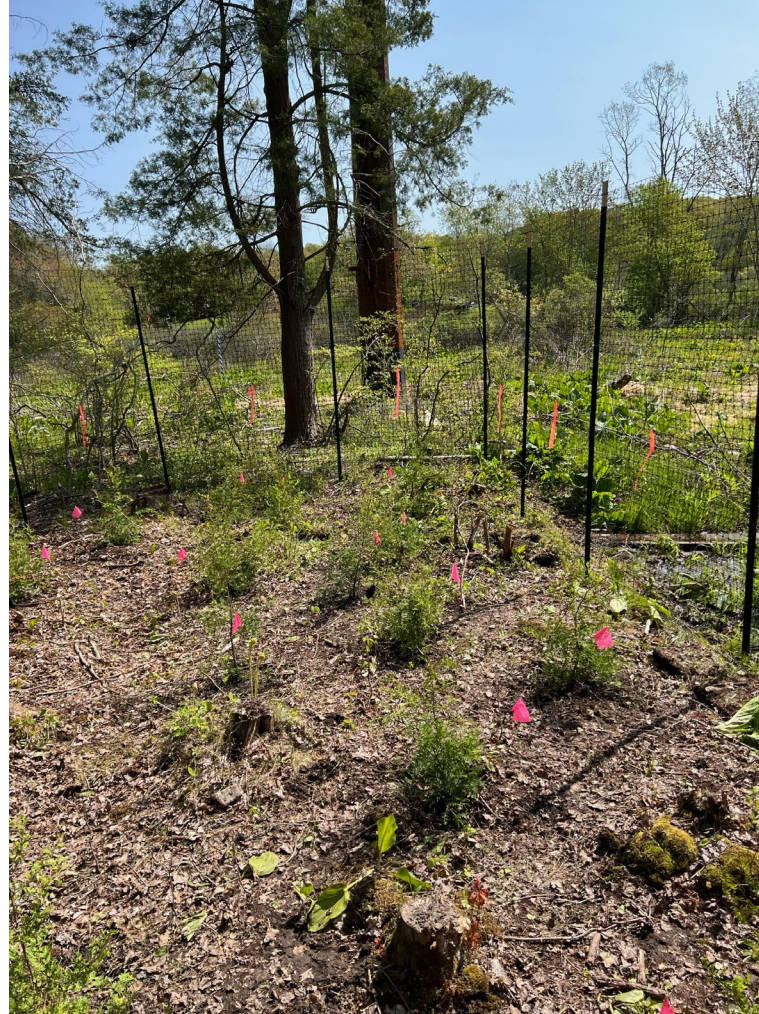
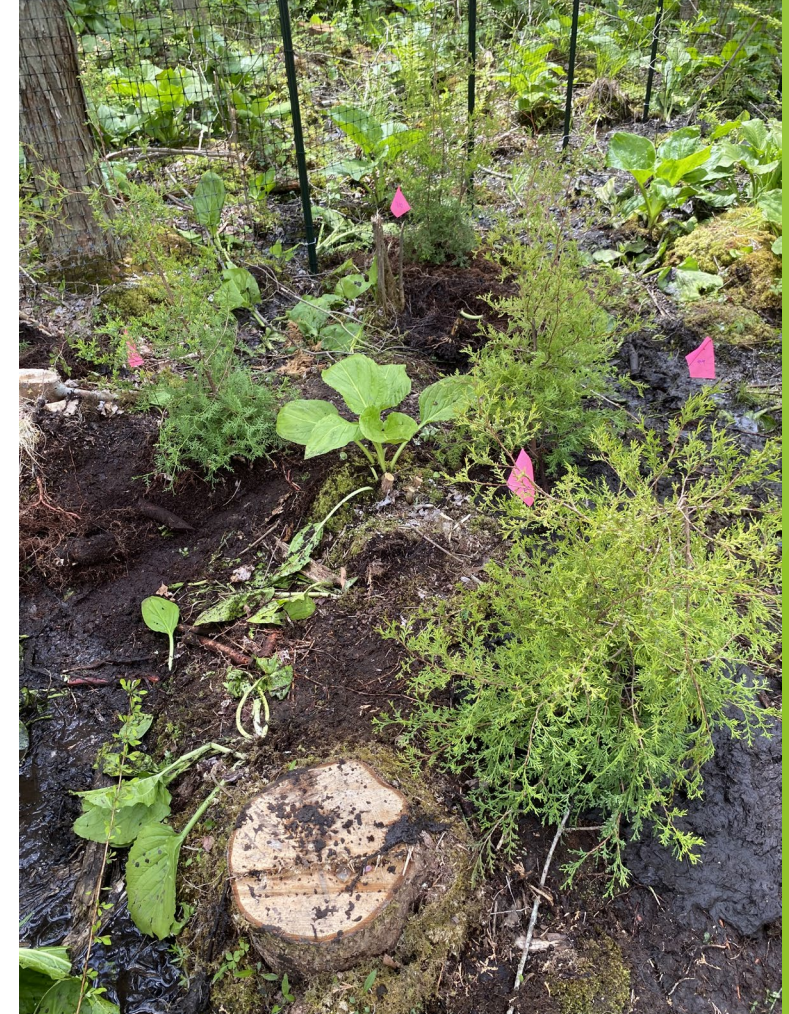
159 AWC saplings
were planted in
April 2023

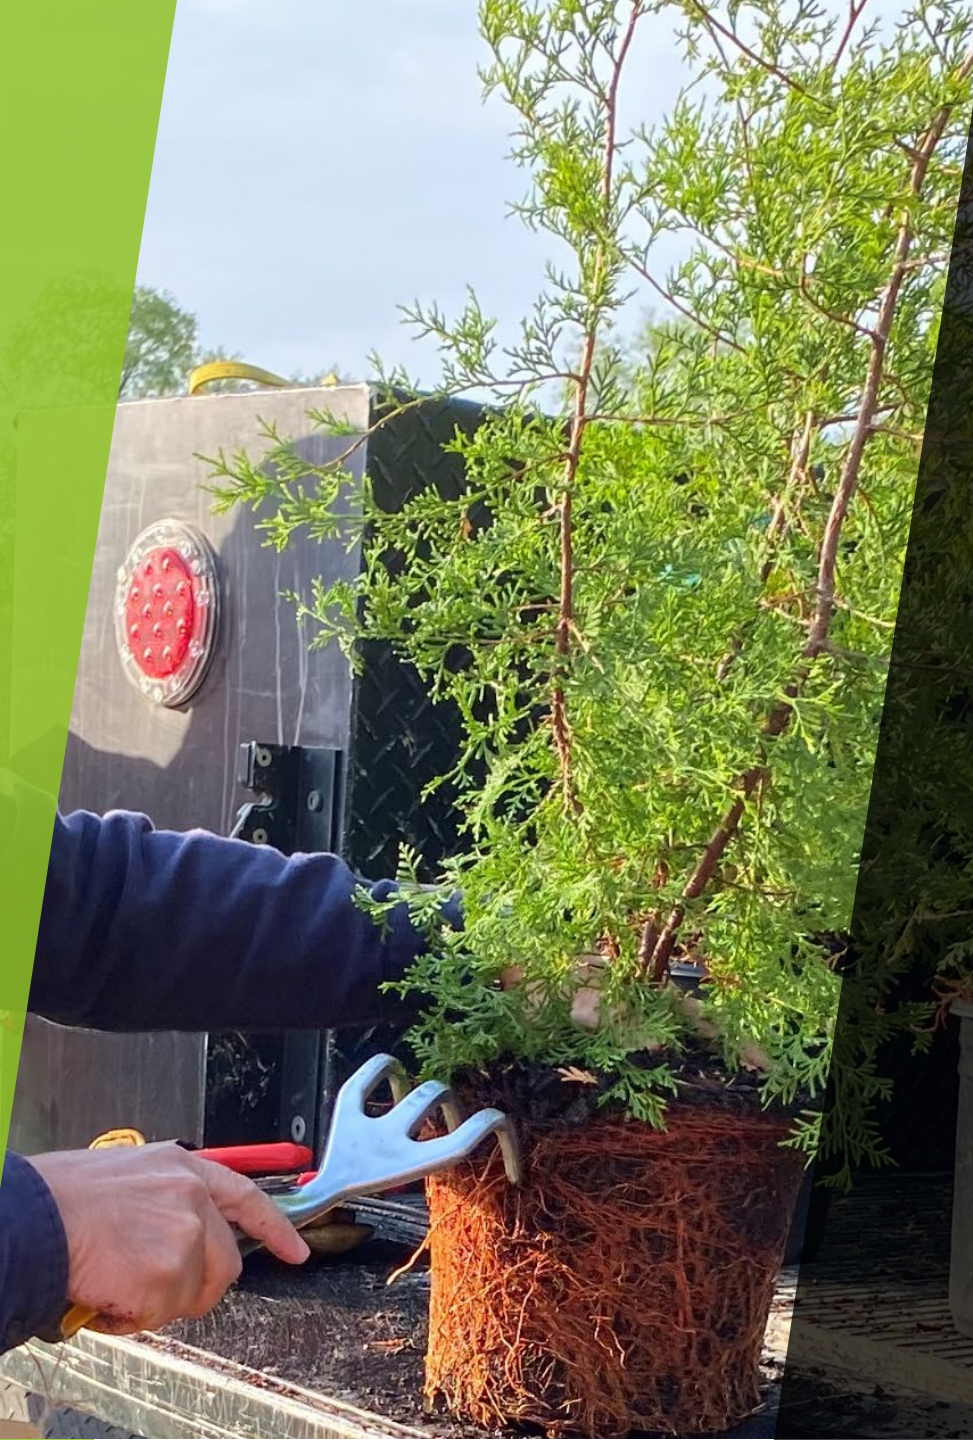
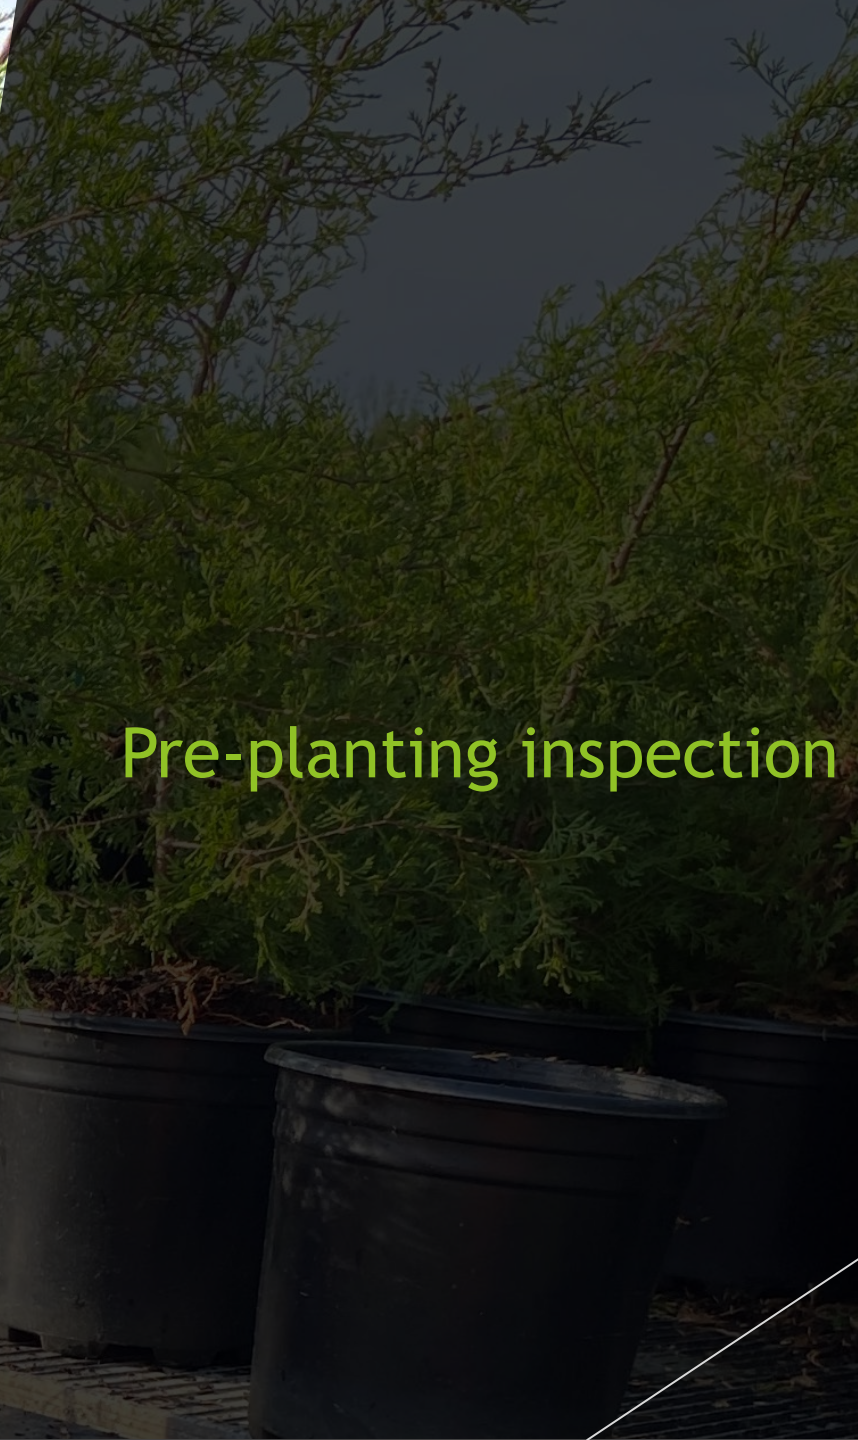
Pre-planting inspection

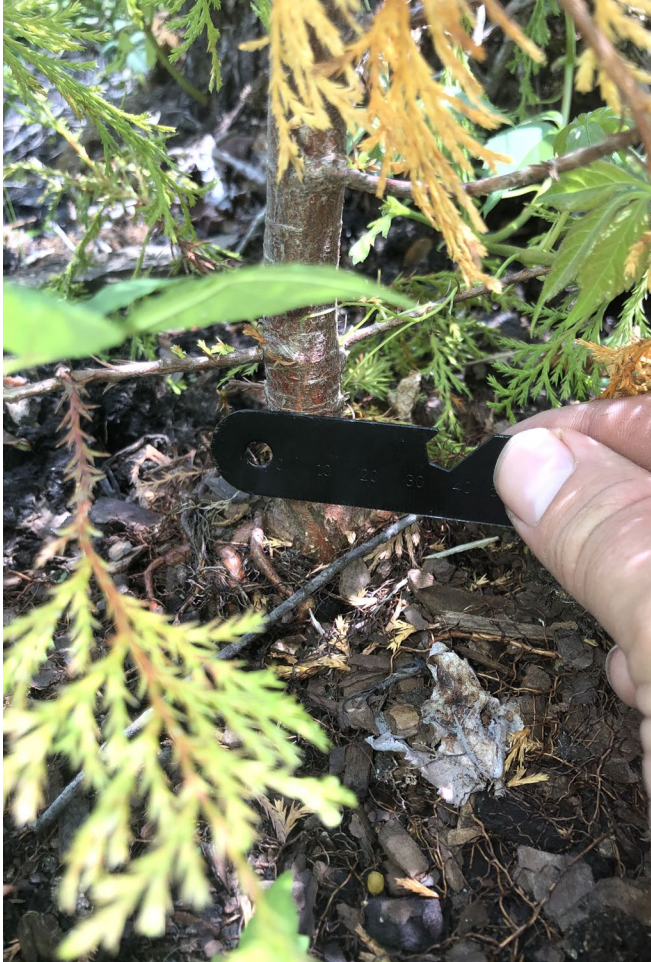
Annual Monitoring Data

- The height/growth of the AWC saplings was determined with a tape measure (to the nearest half-inch).
- Phenology was recorded based on visual observation of fruits or lack thereof.
- Overall comprehensive health:
 - 3 - a sapling with 75% or more green foliage
 - 2 - a sapling with less than 50% yellowing foliage
 - 1 - a sapling with more than 50% yellowing foliage
 - 0 - a sapling with brown foliage or non-surviving sapling
- Vegetative competition was estimated visually and reviewed based on the number of sides and overall coverage of the area experiencing competition by woody vegetation.

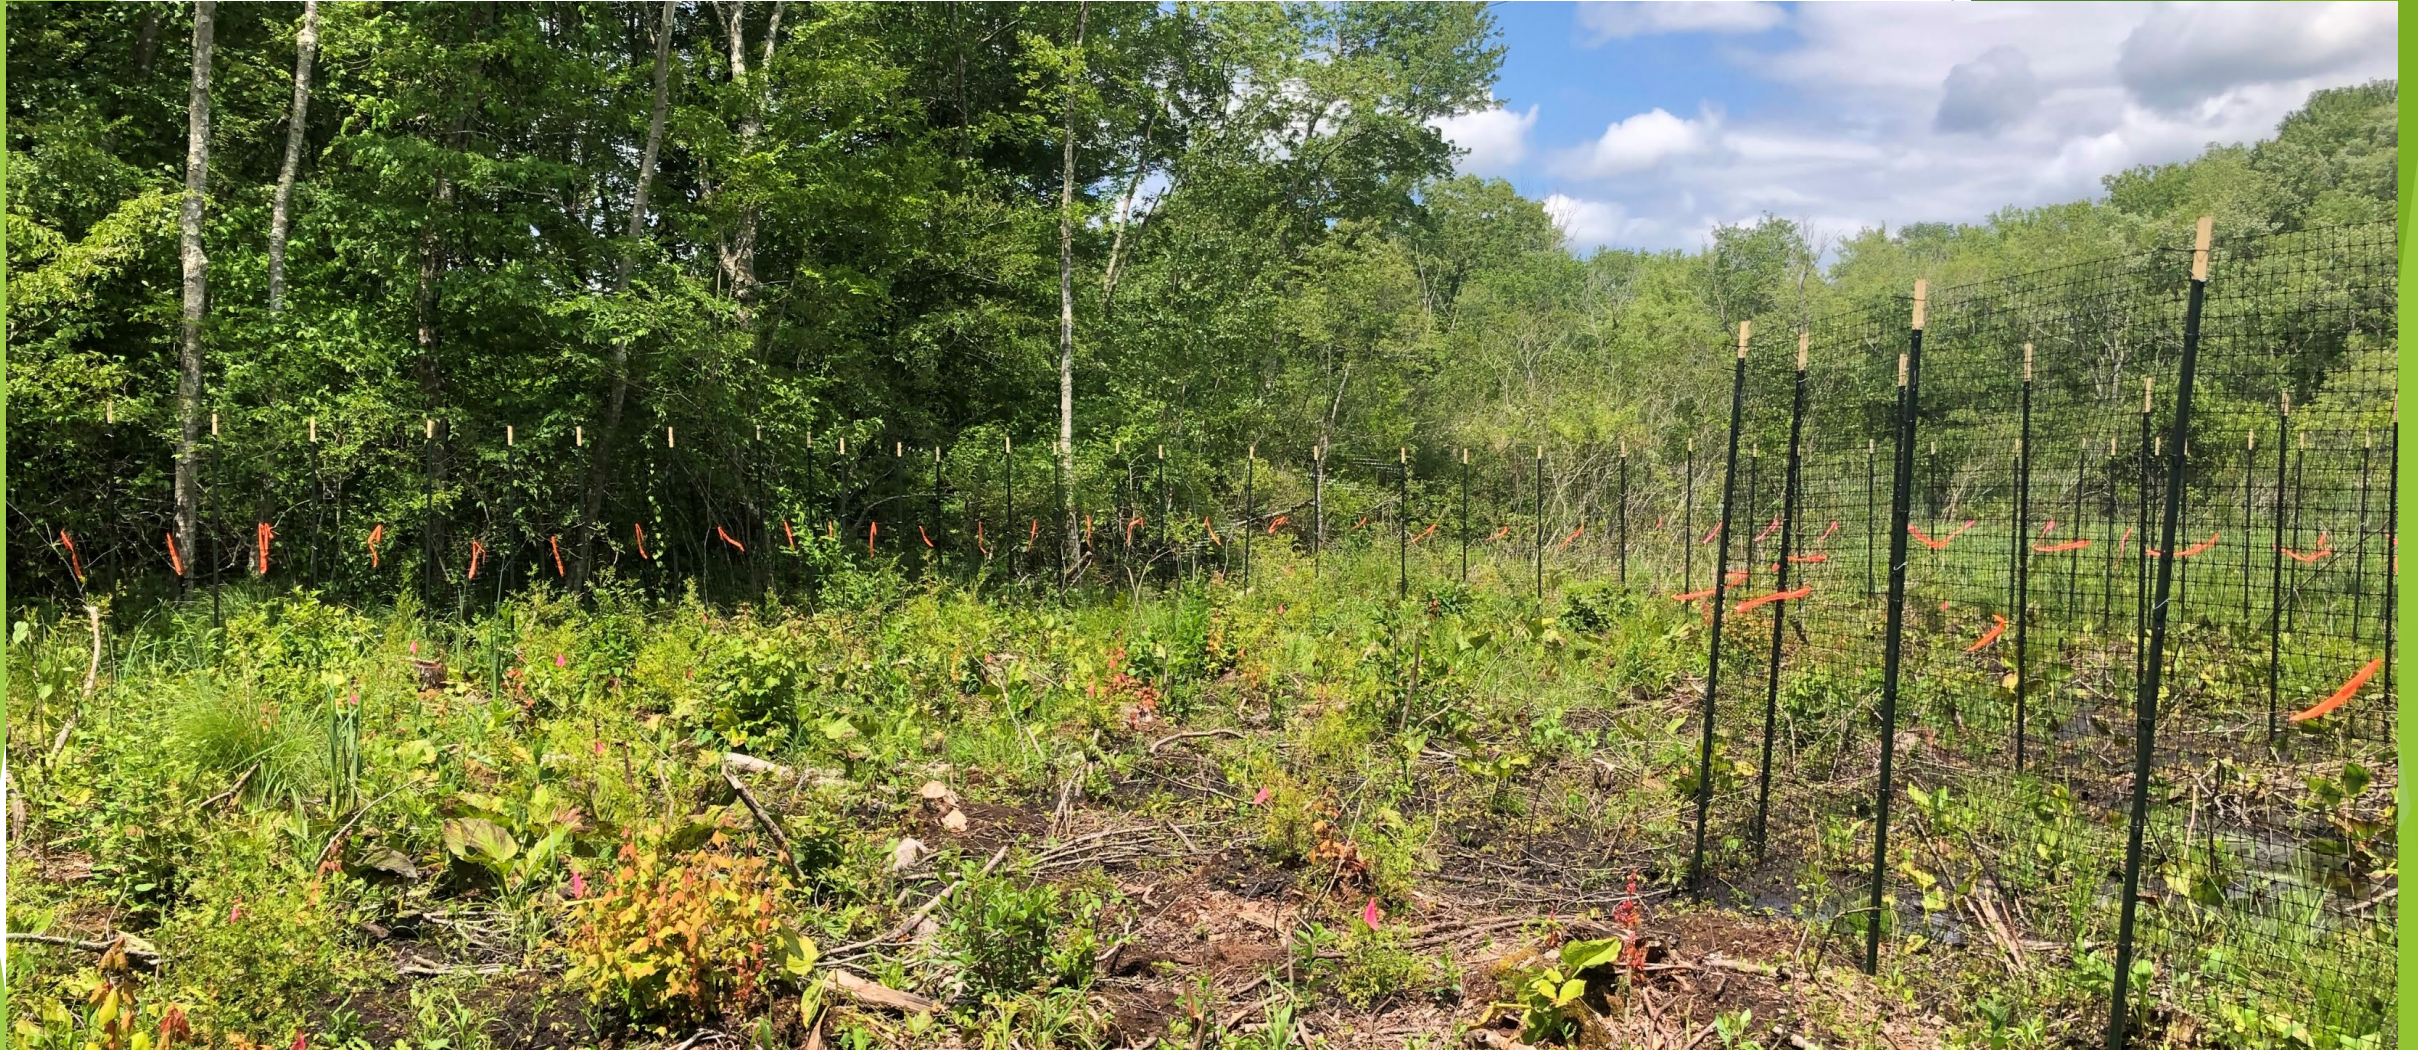
June 2023
