A Special Wetland Eversource Energy's Atlantic White Cedar Mitigation Project - The 1st Year

BSC Group, Inc.

THE PROJECT: Eastern Connecticut Reliability Zone 5 400/500 Lines Rebuild

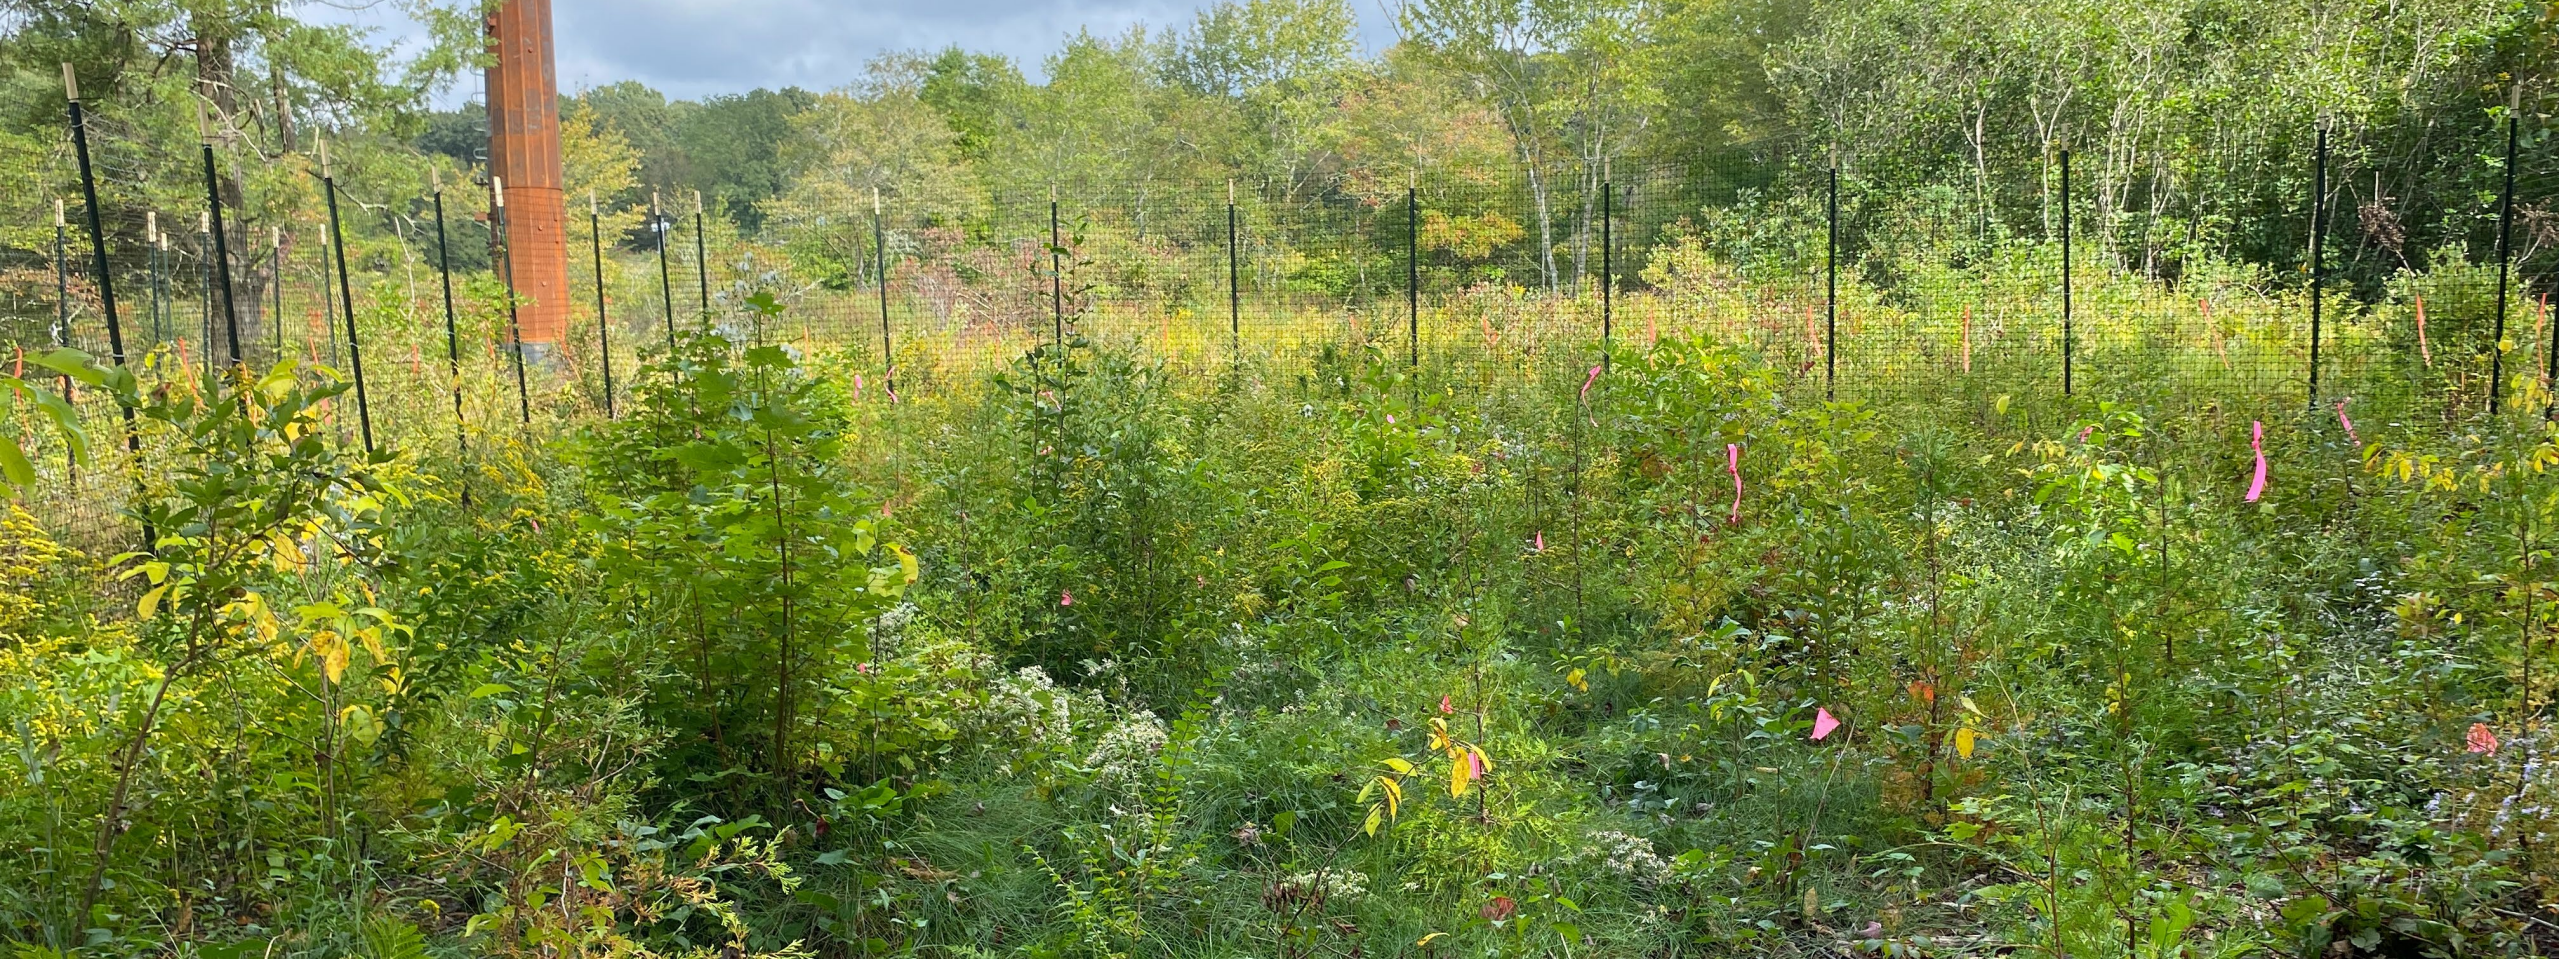
September 2023

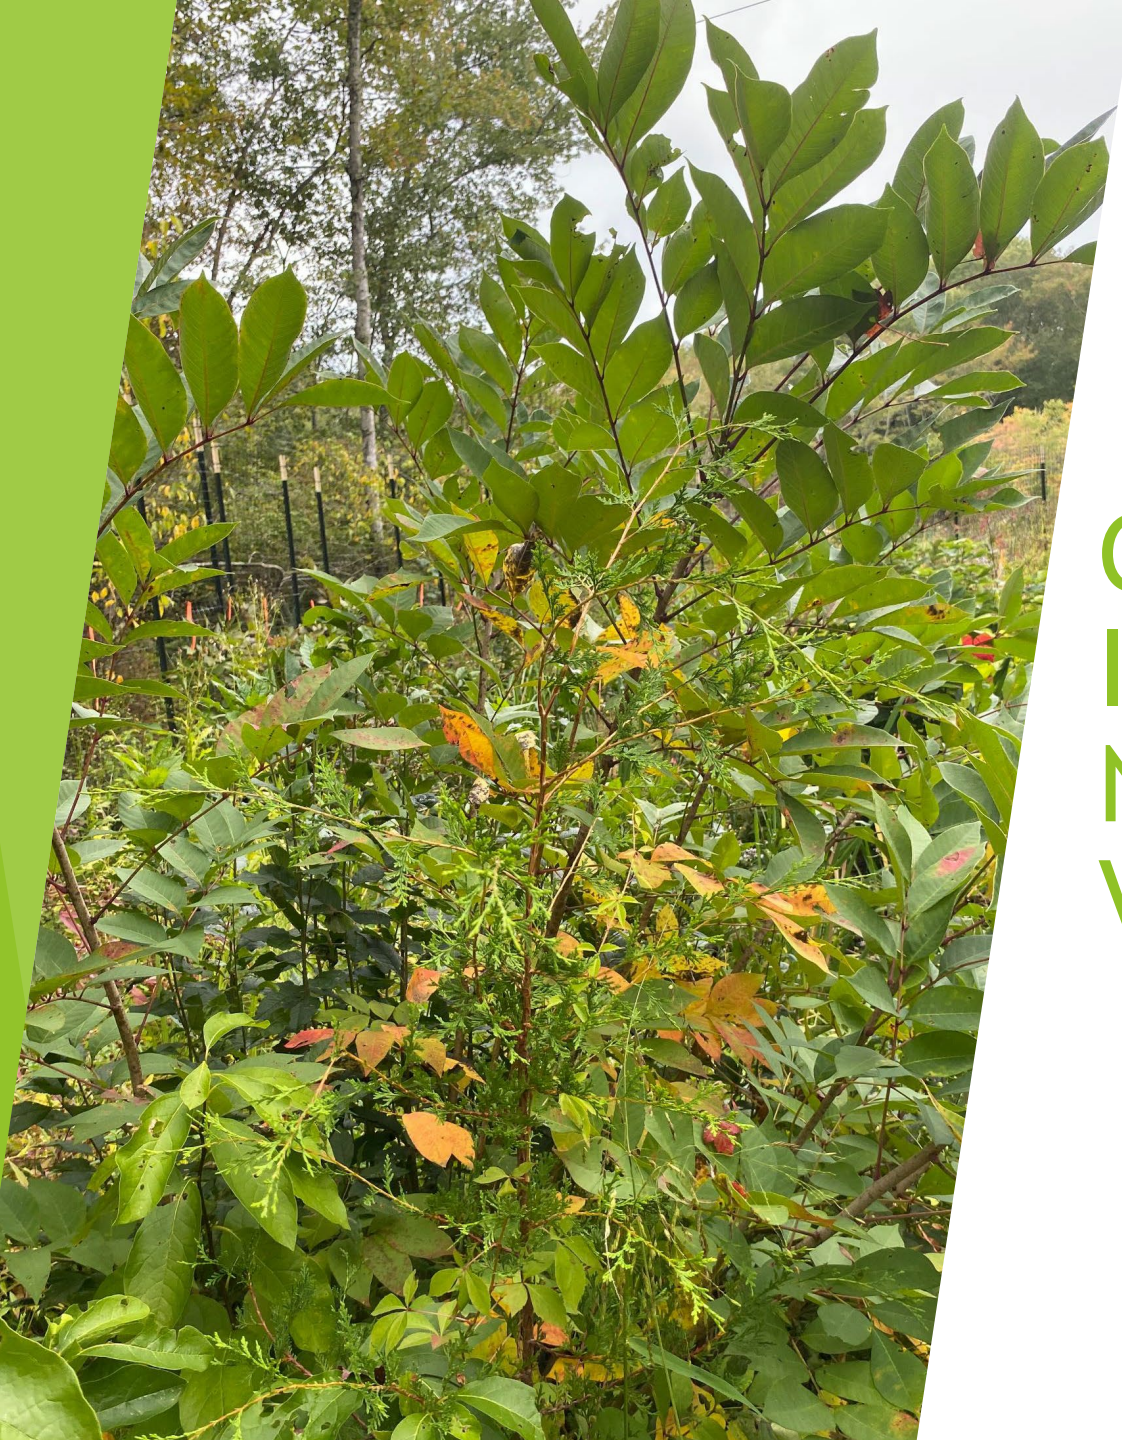
Competition from Invasive Plants and Native Woody Vegetation

- Competing vegetation management
- Manual cutting of easily accessible woody competitors
- Wetland-approved herbicide application (with landowner approval)
- Invasive Plants

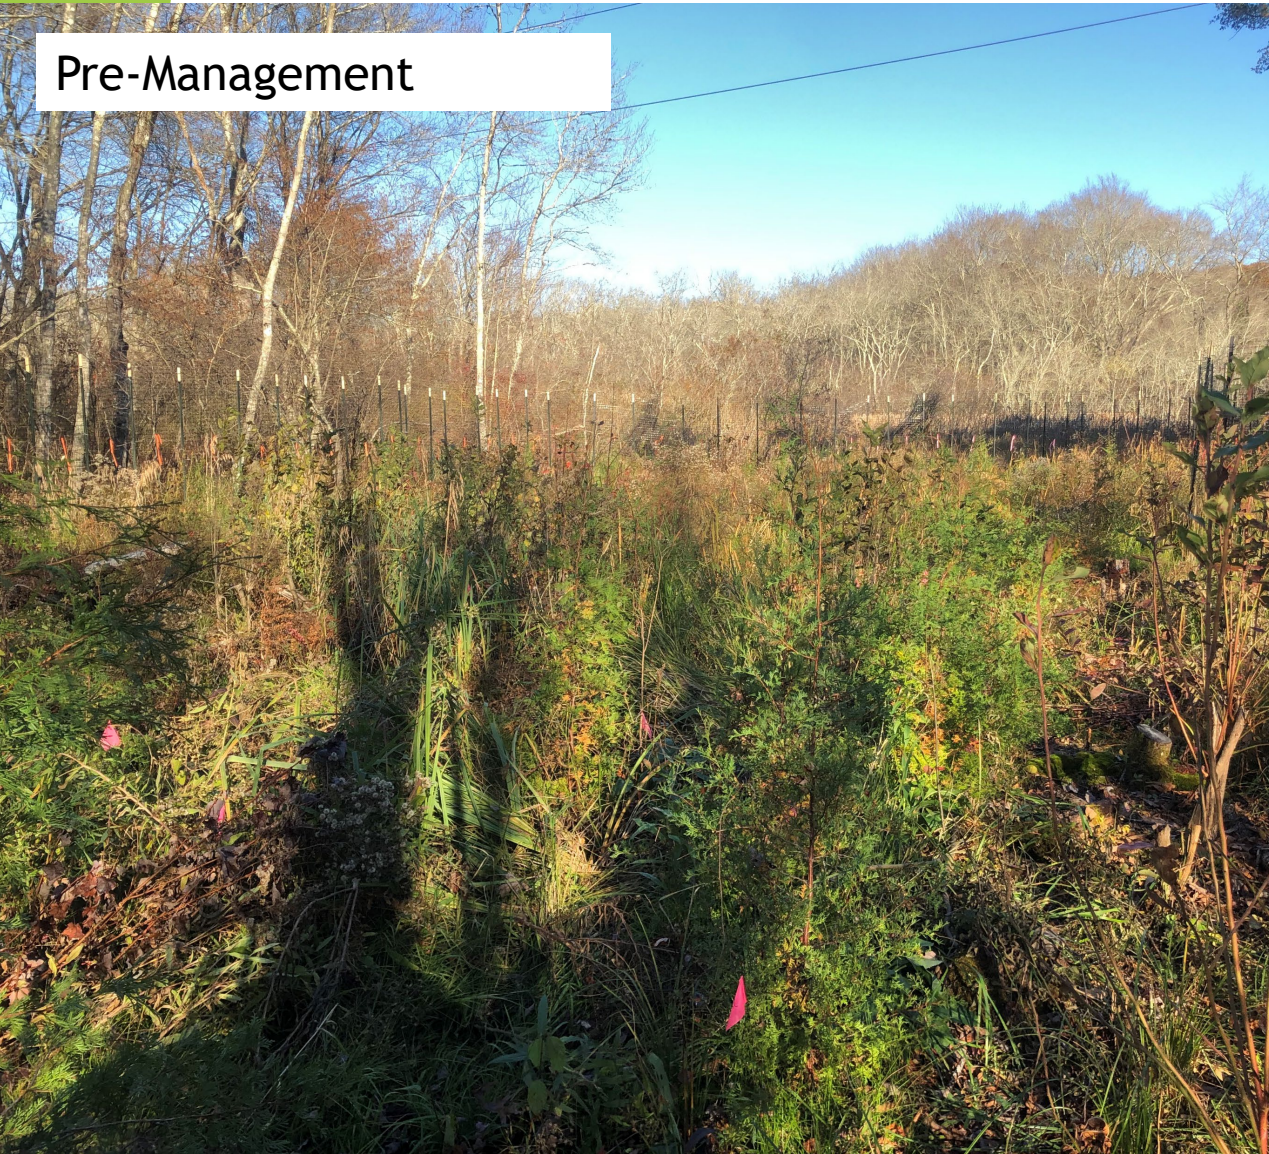
Pre-Management

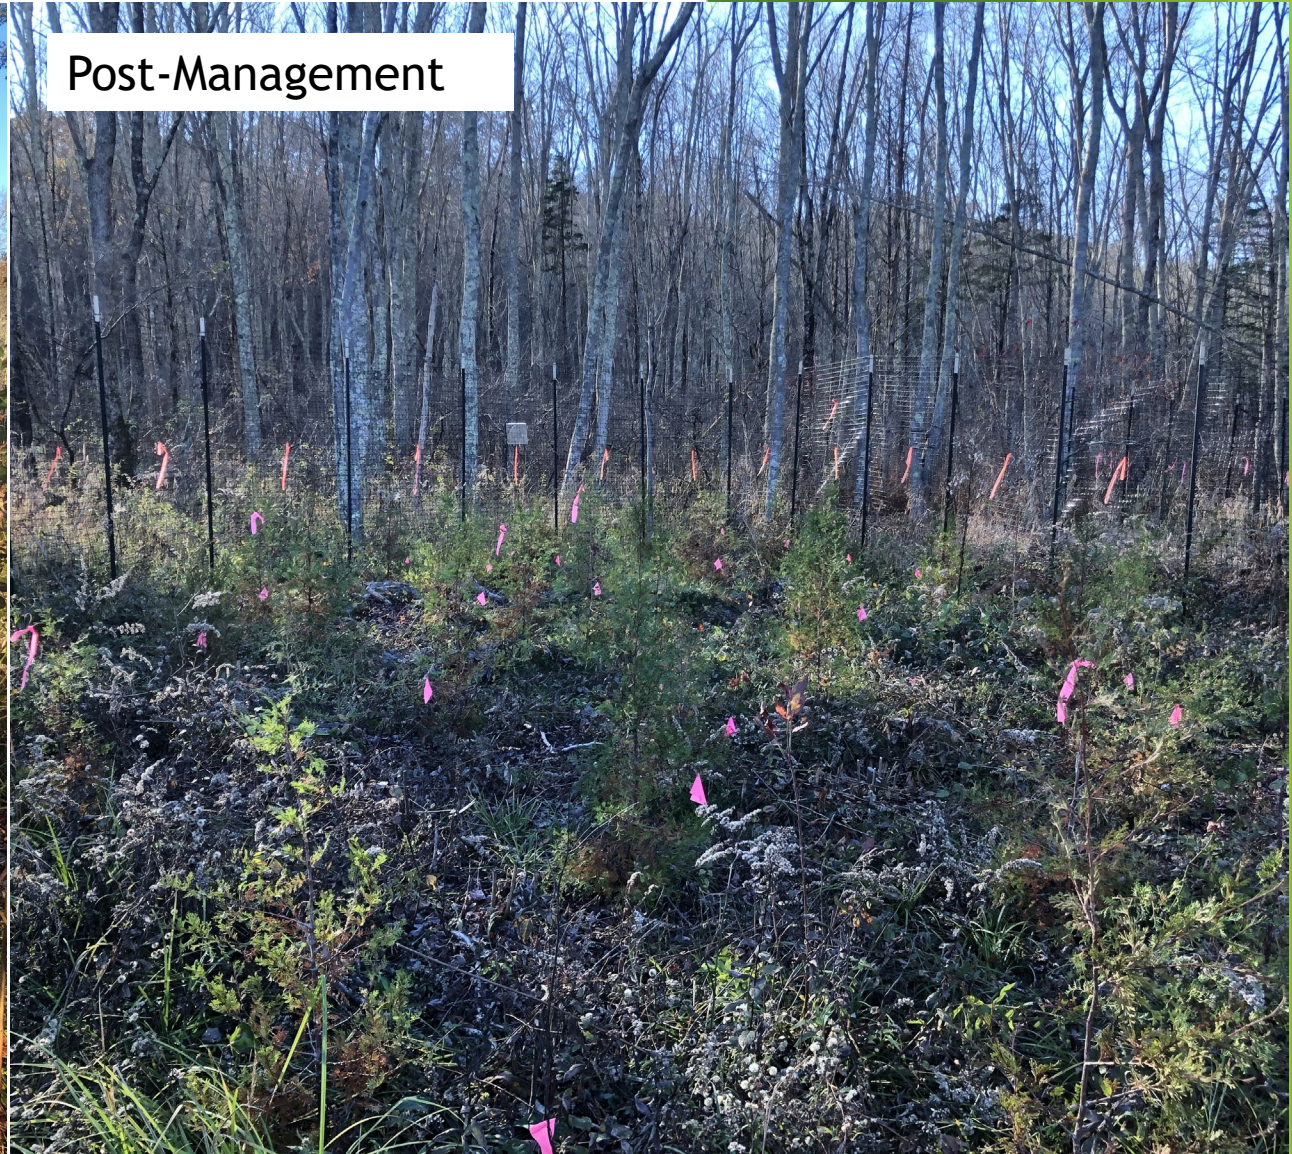
Post-Management
