Vernal Pool Mapping by The Town of Fairfield

*Tim Bishop, MS, CEP, WPIT, CE
Conservation Director*

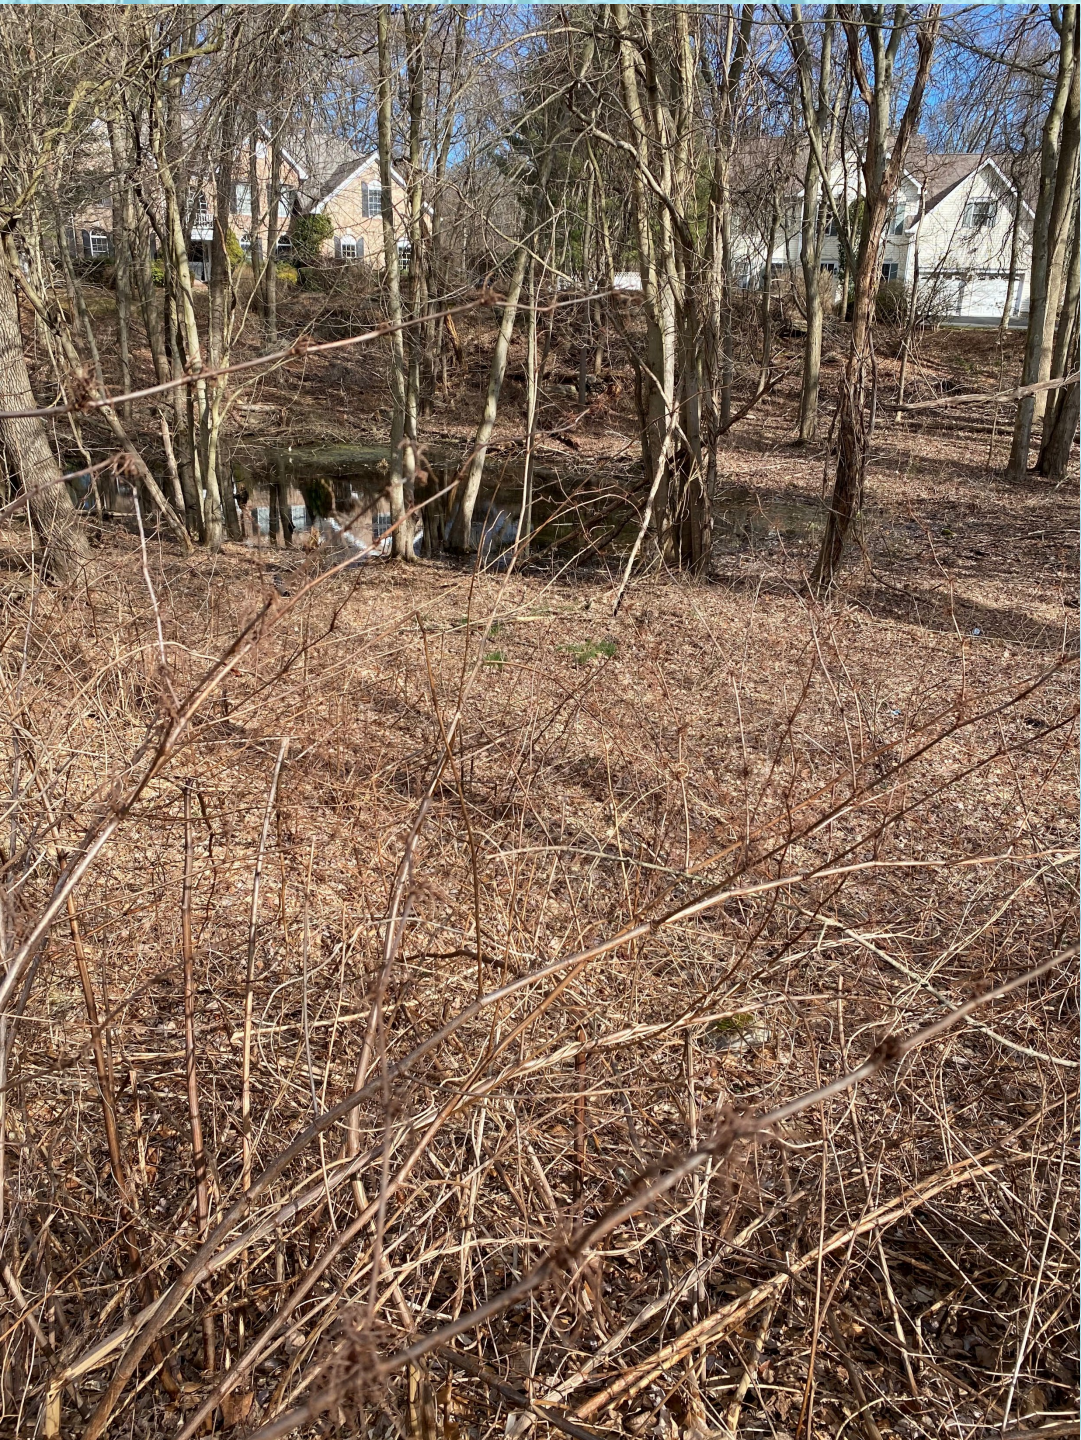
(4-10-00)

Lake Mohegan Open Space -

Northwest quadrant, west side
of river, on both sides of

- power lines, 340 paces due
south from boulder shaped like
a dinosaur, several areas
possible under cover of two
large pin oaks.

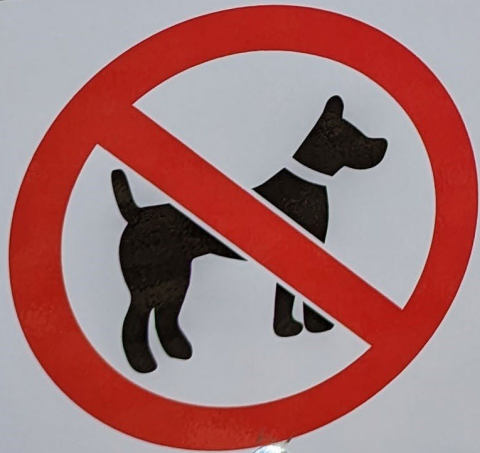
**CRITICAL
AMPHIBIAN
BREEDING
HABITAT**

PLEASE KEEP DOGS OUT
FEBRUARY THROUGH JUNE
