Stratford point living shoreline: maintaining habitat connectivity surrounding wetlands.

Biology Department, Sacred Heart University

The Restoration Site, Stratford Pt.

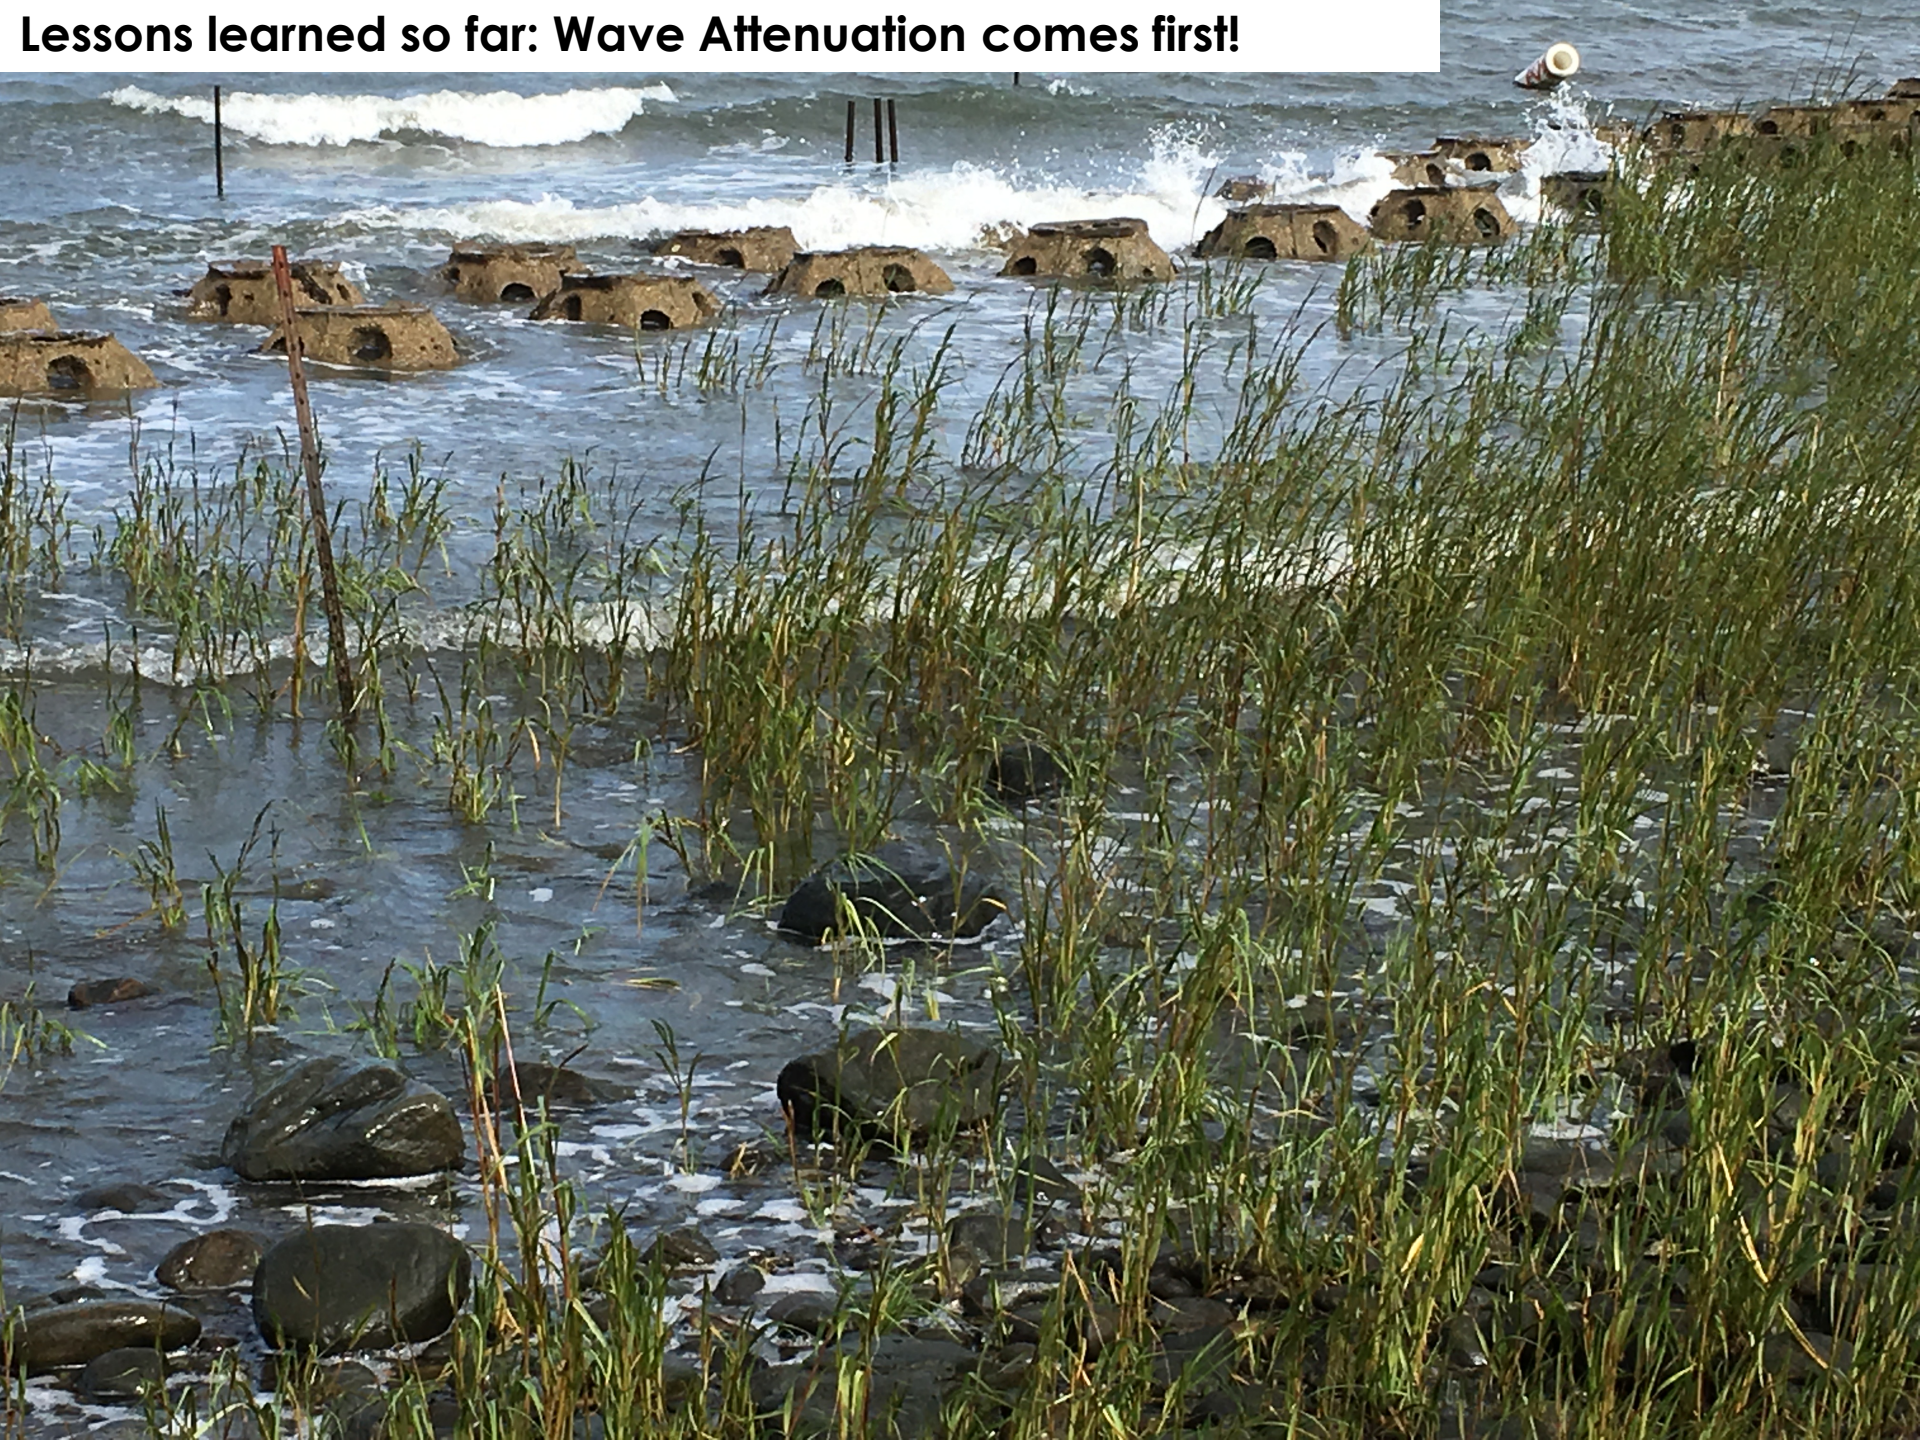
Pilot Study of 64 reef balls installed May, 2014 ~150 feet

- 30-40% Wave Abatement (pilot reef)
- *Spartina alterniflora* doubling in size over one year and average density is equal to reference marsh on Milford Point.
- >30cm Sediment Deposited Behind The Reef In 2 Years
- Lead Is No Longer Exposed Behind The Pilot Reef
- Rockweed, Oysters and Others Surviving On The Reef

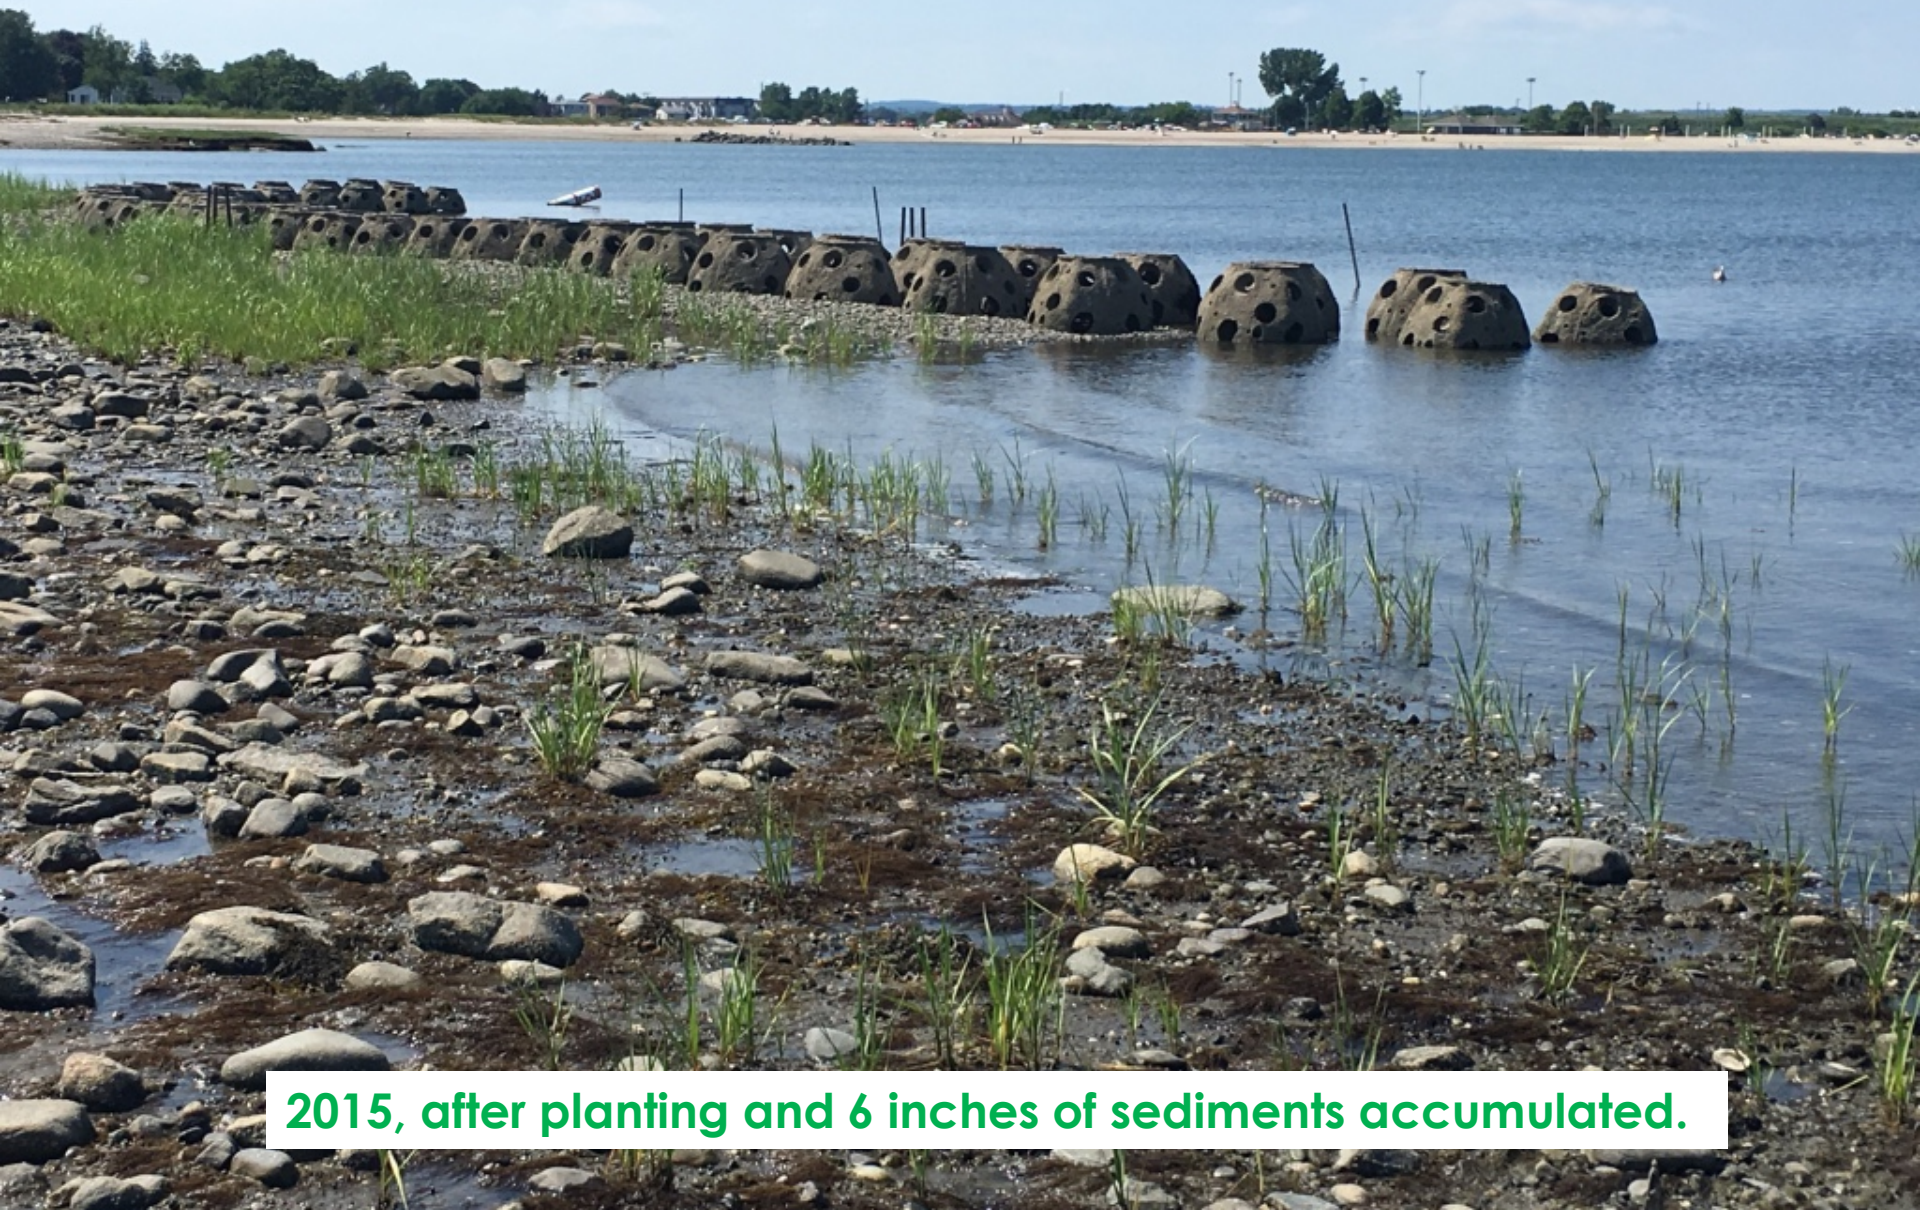
2015, after planting and 6 inches of sediments accumulated.

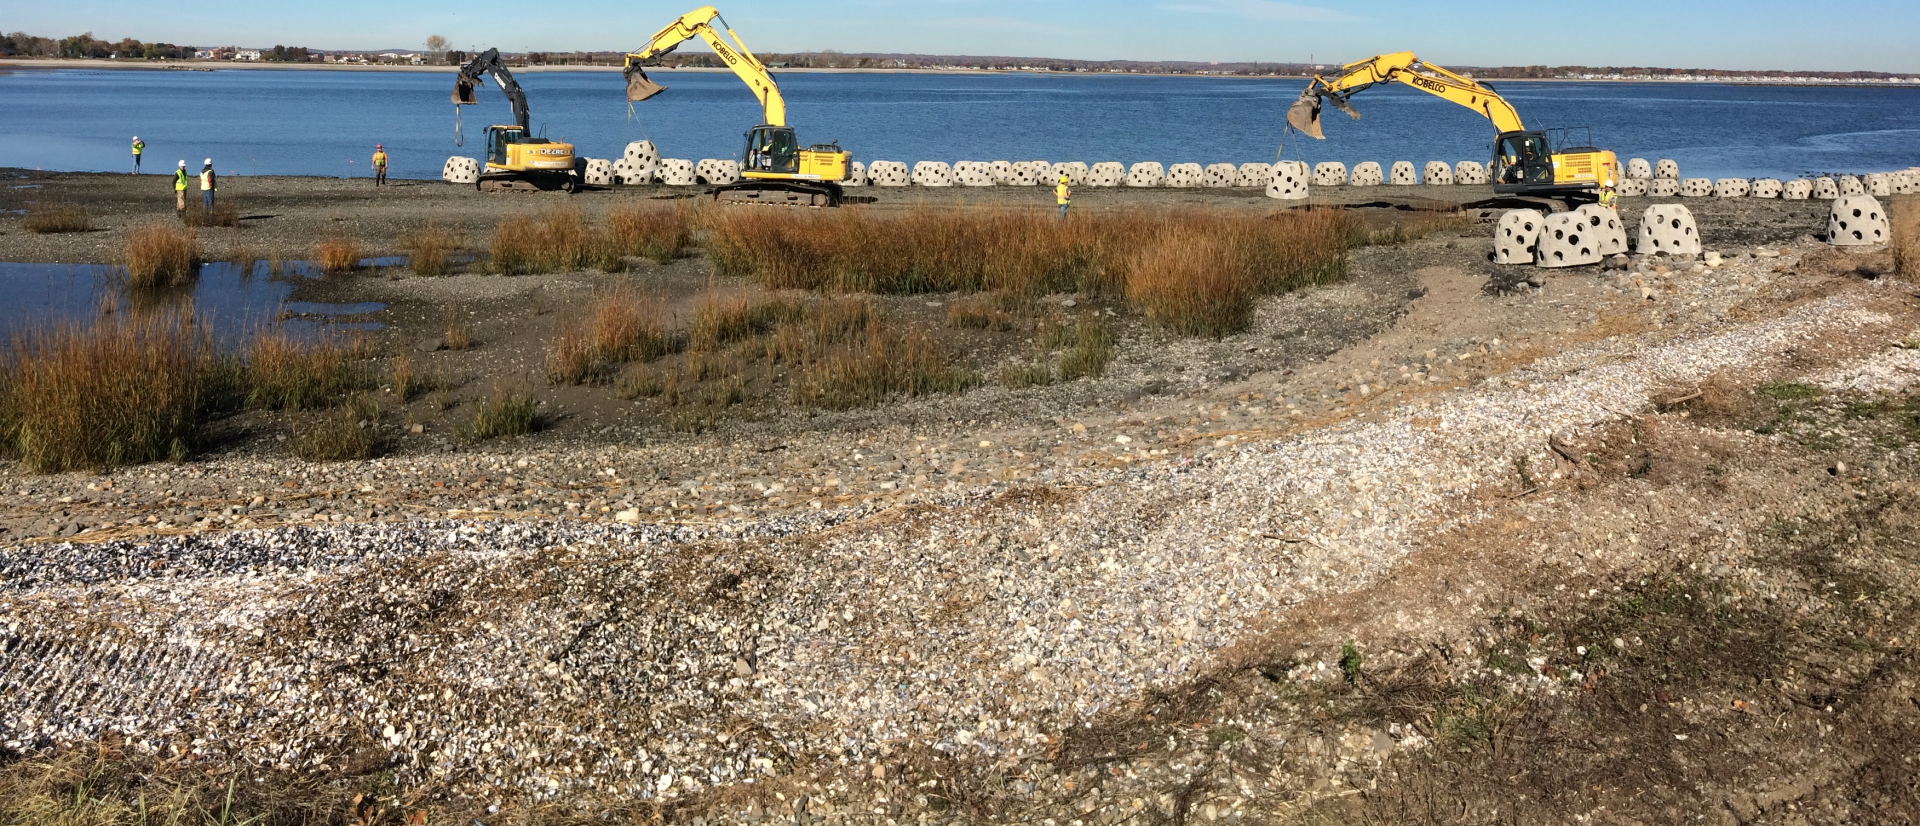
November 2016 Reef expansion ~300m 327 reef balls deployed

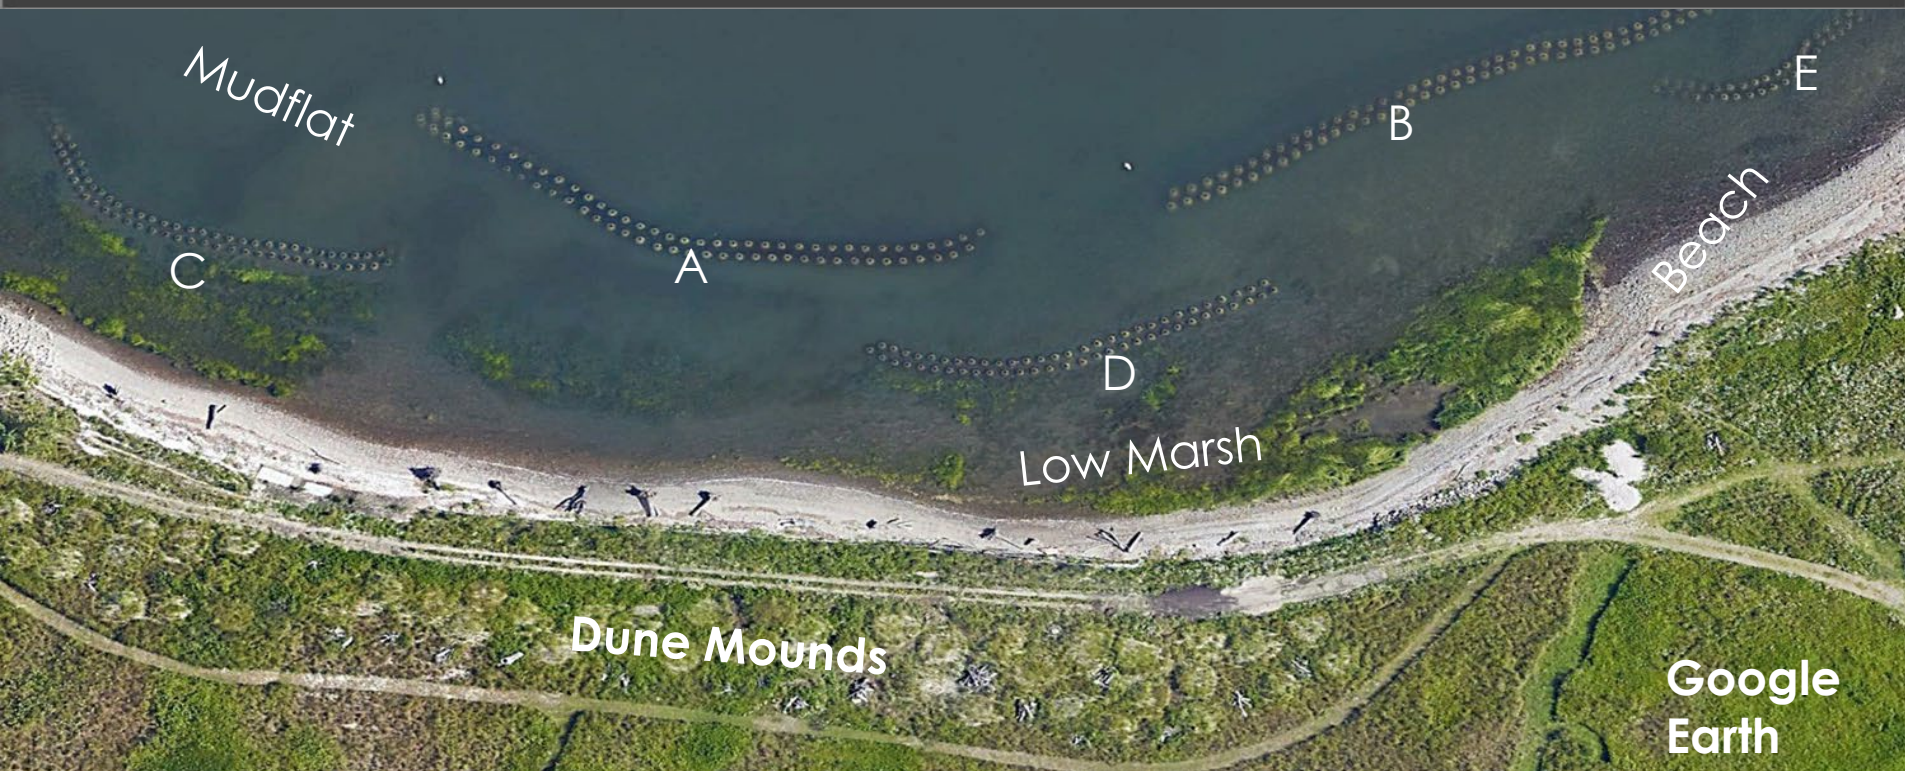
TOTAL NUMBER OF CRASSOSTREA VIRGINICA COUNTED AT STRATFORD POINT

2018 2019 2020

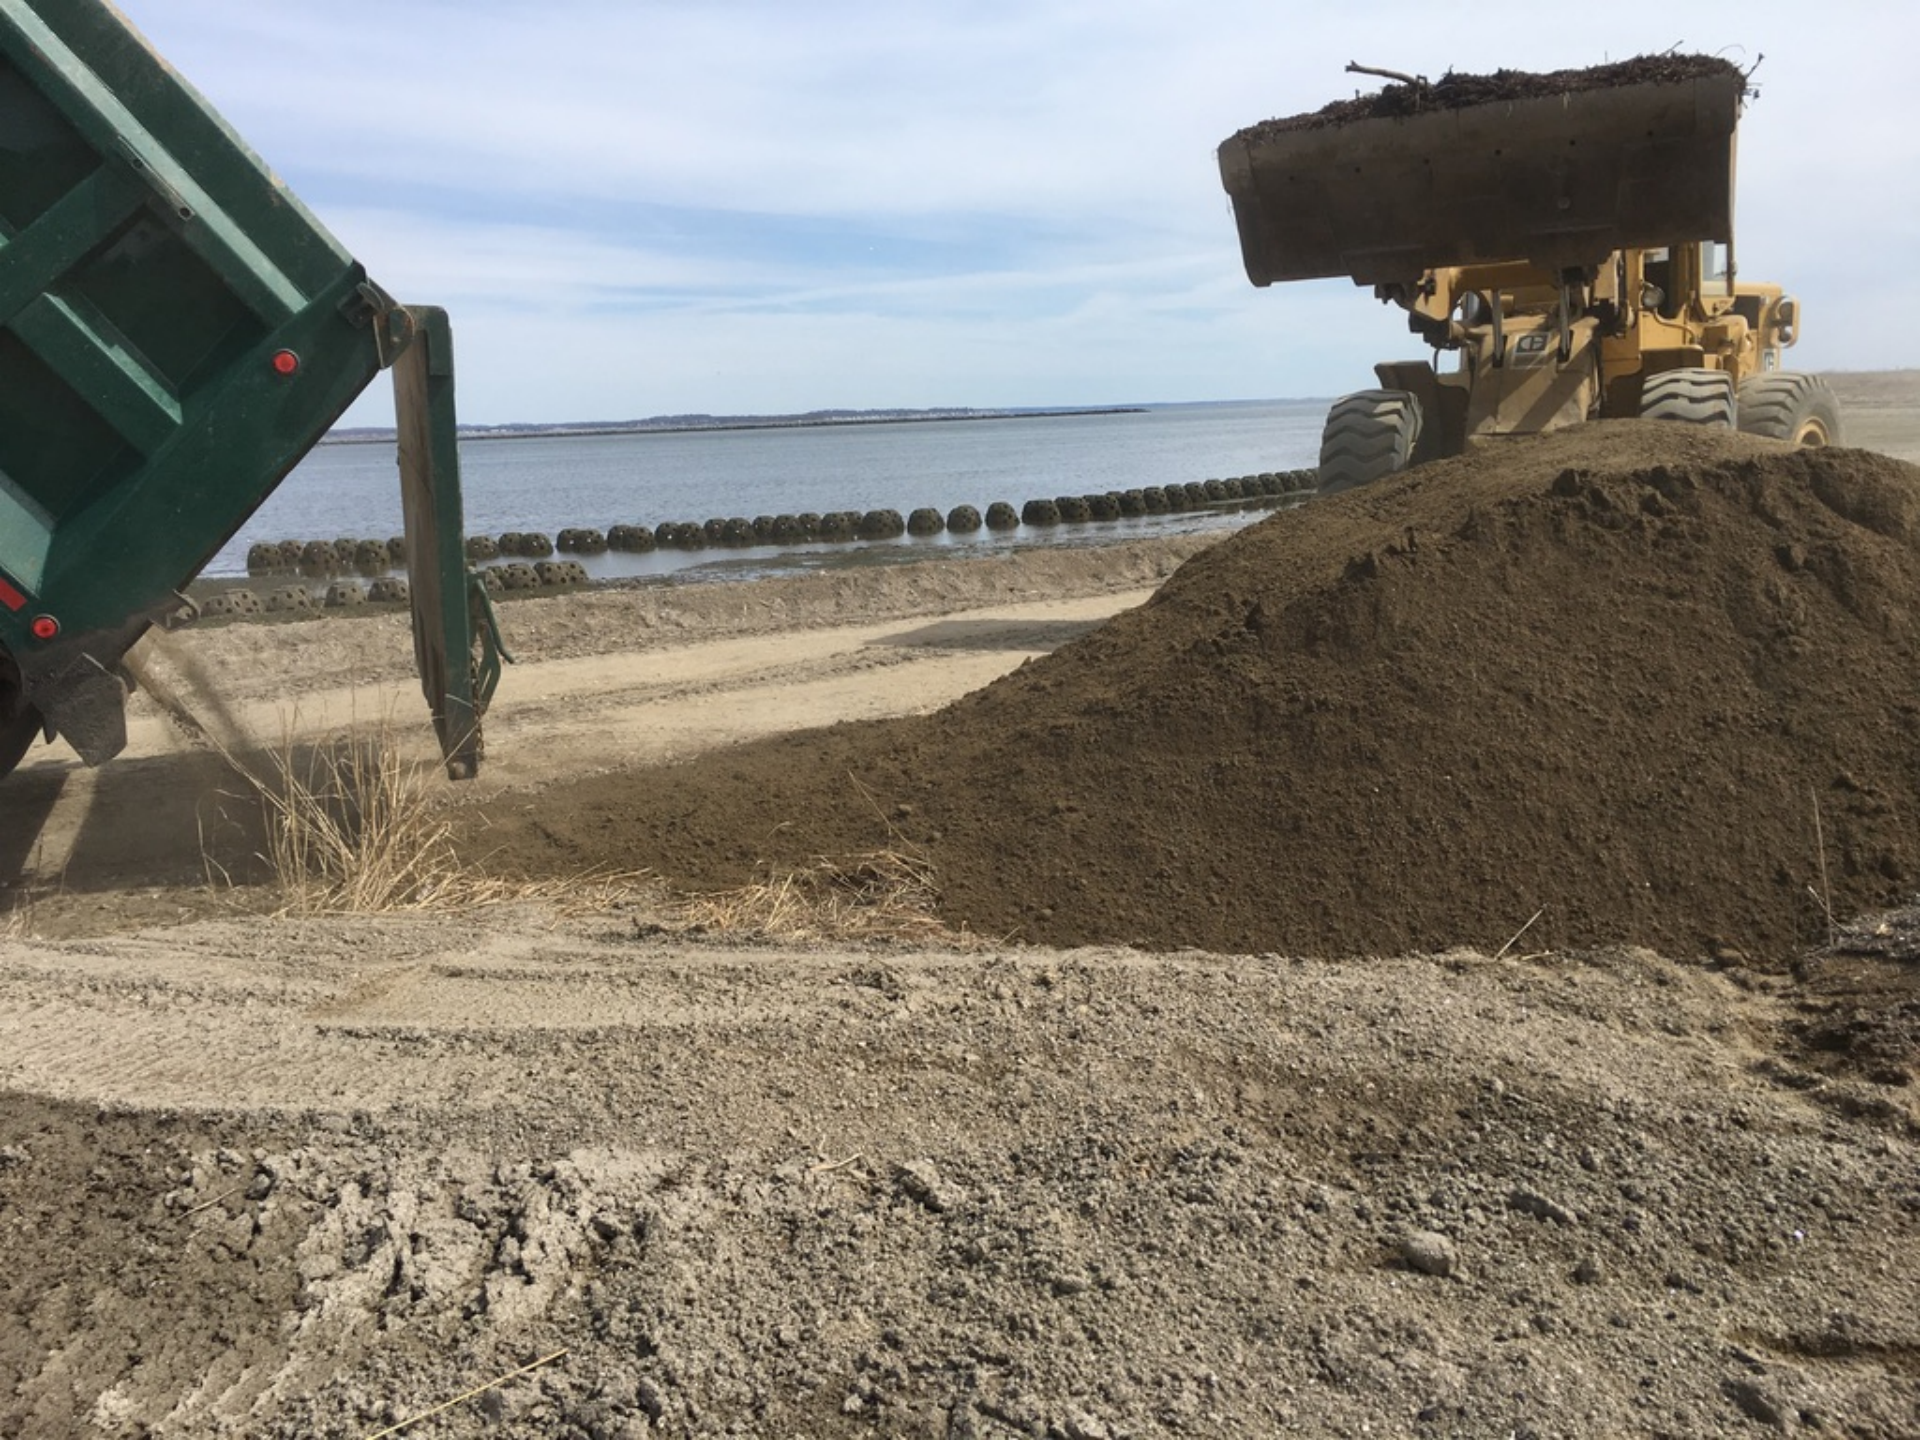
An aerial photograph of a coastal restoration site. In the foreground, there are several long, curved rows of small, light-colored, cylindrical grass plugs planted in a sandy area. A body of water is visible in the upper left, and a road or path runs along the right side of the site. The background shows more of the coastal landscape with some vegetation and structures.

Grass plugs (2") from Pinelands Nursery

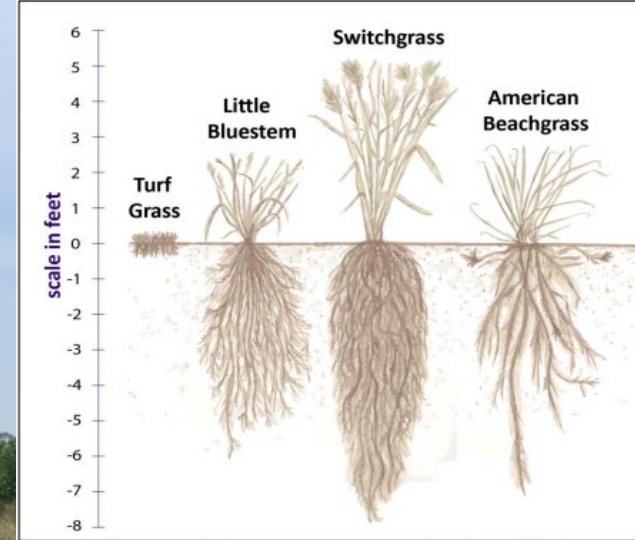
Turf grass has a very shallow root system compared to these other plants recommended for erosion control. (Figure redrawn from illustration by Dede Christopher of the Tennessee Valley Authority, Benefits of Riparian Zones)
